**International Committee of the Red Cross (ICRC)  
Somalia Delegation**

**Water Resources Assessment, Water Supply  
Planning and Rehabilitation Surveys;  
Hydrogeological & Geophysical Surveys**

**Gedo Region - Somalia**

**January / February 2002**

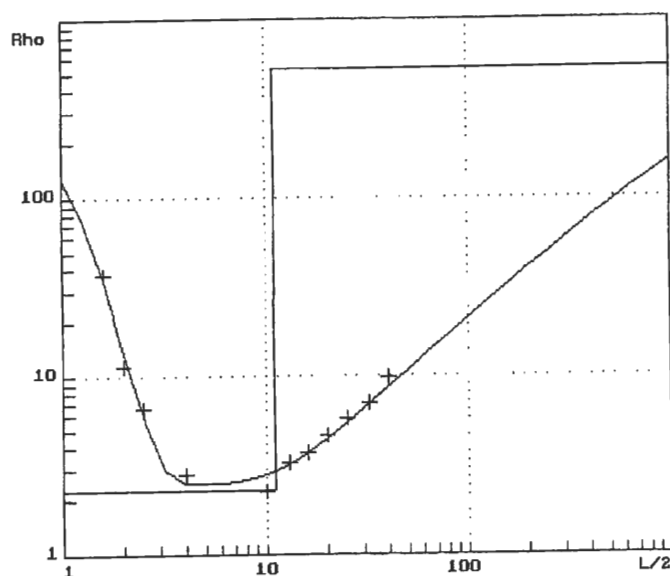
**Figure 17 - Interpretation Graph for VES 11**

The interpretation results indicate a 340 Ohm-m superficial layer to 0.5 m bgl, comprising sandy soil, underlain by a 2.3 Ohm-m layer to a depth of 11 m bgl comprising clays and silts. This is underlain by a 50 Ohm-m resistivity layer interpreted to be weathered limestones and sandstones. No aquifers are expected at this location.

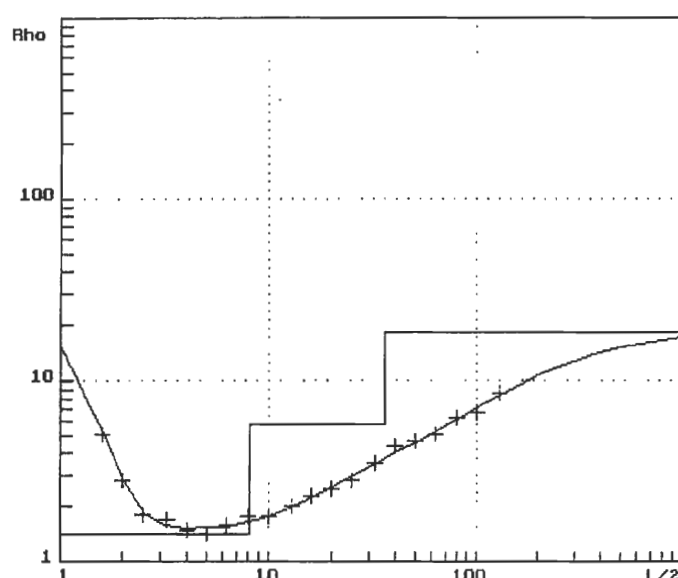
**Figure 21 - Interpretation Graph for VES 13**

The VES interpretation results indicate a superficial layer of 42 Ohm-m to a depth of 0.4 m bgl, comprising mainly Recent alluvial deposits and sandy top soils underlain by a 1.4 Ohm-m resistivity layer to a depth of 8 m bgl comprising clays probably very salty. This is underlain by a 6 Ohm-m resistivity layer to a depth of 36 m bgl corresponding to highly weathered limestones and clays. It is underlain by a 19 Ohm-m layer interpreted to be slightly weathered limestones, sandstones and siltstones.

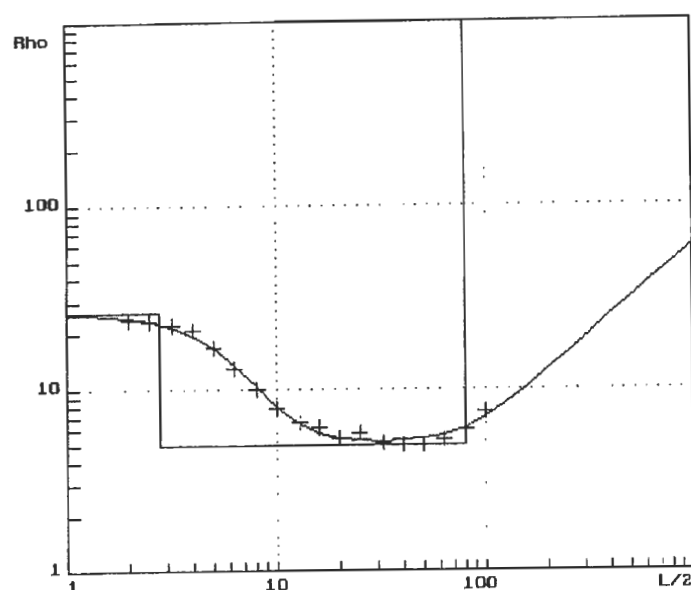
Figure 25 - Interpretation Graph for VES 16

The VES interpretation results indicate a superficial layer of 26 Ohm-m to a depth of 2.8 m bgl, comprising mainly Recent alluvial deposits and sandy top soils underlain by a 5 Ohm-m resistivity layer to a depth of 80 m bgl comprising clays, most probably very salty. This is underlain by a 995 Ohm-m resistivity layer corresponding to hard compact limestones, sandstones and siltstones.

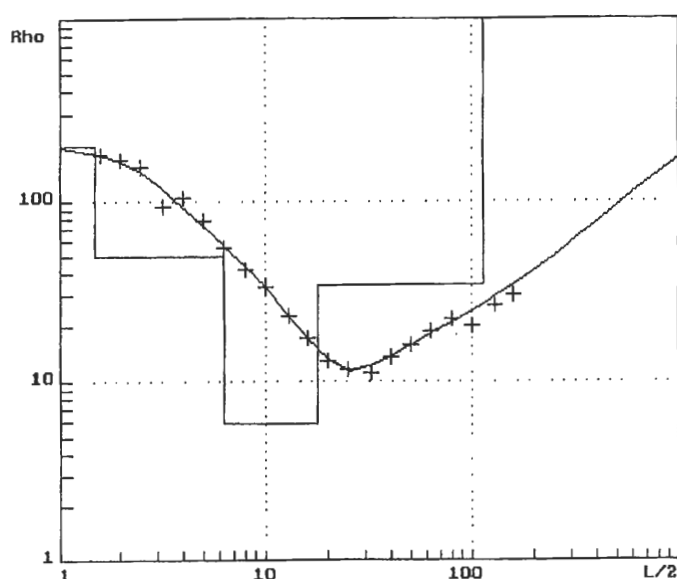
Figure 30 - Interpretation Graph for VES 22

The VES interpretation results indicate a superficial layer of 204 Ohm-m to a depth of 1.5 m bgl, comprising mainly Recent deposits composed of top sandy soils, underlain by a 50 Ohm-m resistivity layer to a depth of 6 m bgl comprising weathered limestone. This is underlain by a 6 Ohm-m resistivity layer to a depth of 18 m corresponding to highly weathered limestones and clays. It is underlain by a 34 Ohm-m layer to a depth of 113 m bgl. This comprises weathered limestones with brackish water. At the bottom is a 1000 Ohm-m resistivity layer interpreted to be hard compact limestones and sandstones.

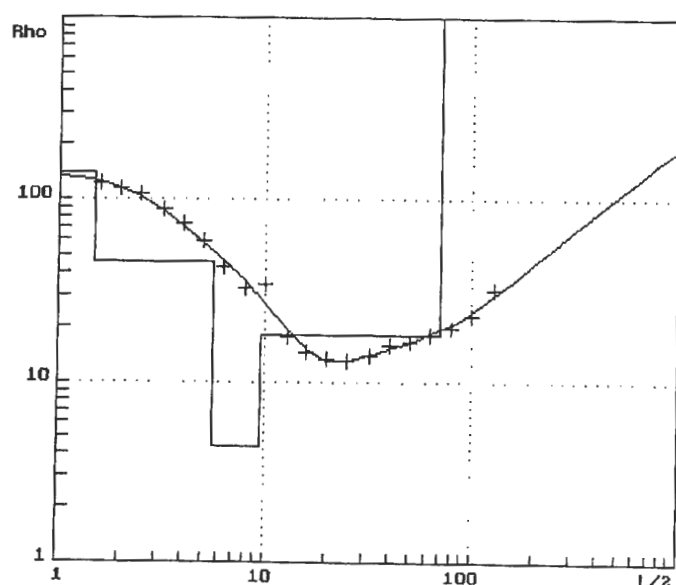
**Figure 31 - Interpretation Graph for VES 23**

The VES interpretation results indicate a superficial layer of 138 Ohm-m to a depth of 1.5 m bgl, comprising mainly Recent deposits composed of top sandy soils, underlain by a 45 Ohm-m resistivity layer to a depth of 6 m bgl comprising weathered sandstones. This is underlain by a 4 Ohm-m resistivity layer to a depth of 9.5 m bgl corresponding to highly weathered sandstones and clays. It is underlain by a 18 Ohm-m layer to a depth of 70 m bgl. This comprises weathered sandstones with brackish water. The bottom layer is a 1000 Ohm-m resistivity layer interpreted to be hard compact sandstones.

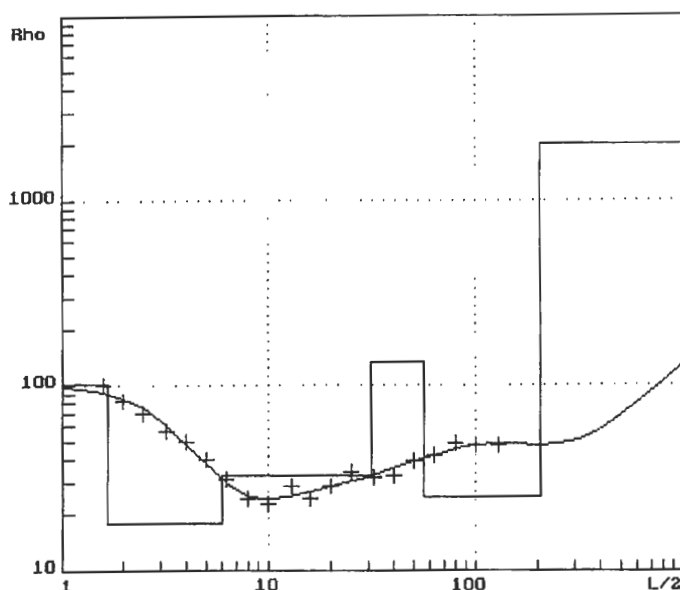
Figure 36 - Interpretation graph of VES 28

The VES interpretation results indicate a superficial layer of 102 Ohm-m resistivity to a depth of 1.7 m bgl, comprising Recent deposits composed of sandy soils, underlain by a 18 Ohm-m resistivity layer to a depth of 6 m bgl comprising highly weathered sandstones. This is underlain by a 33 Ohm-m resistivity layer to a depth of 31 m bgl corresponding to weathered sandstones. This is underlain by a 134 Ohm-m resistivity layer to a depth of 56 m bgl interpreted to be compact sandstones. It is underlain by a 25 Ohm-m resistivity layer to a depth of 206 m bgl interpreted to be highly weathered sandstones with fresh water. The bottom layer is a 2000 Ohm-m resistivity layer interpreted to be hard compact sandstones.
