**Somali Democratic Republic
Ministry of Agriculture**

Farahaane Irrigation Rehabilitation Project

Topographical and Cadastral Survey Report

December 1987

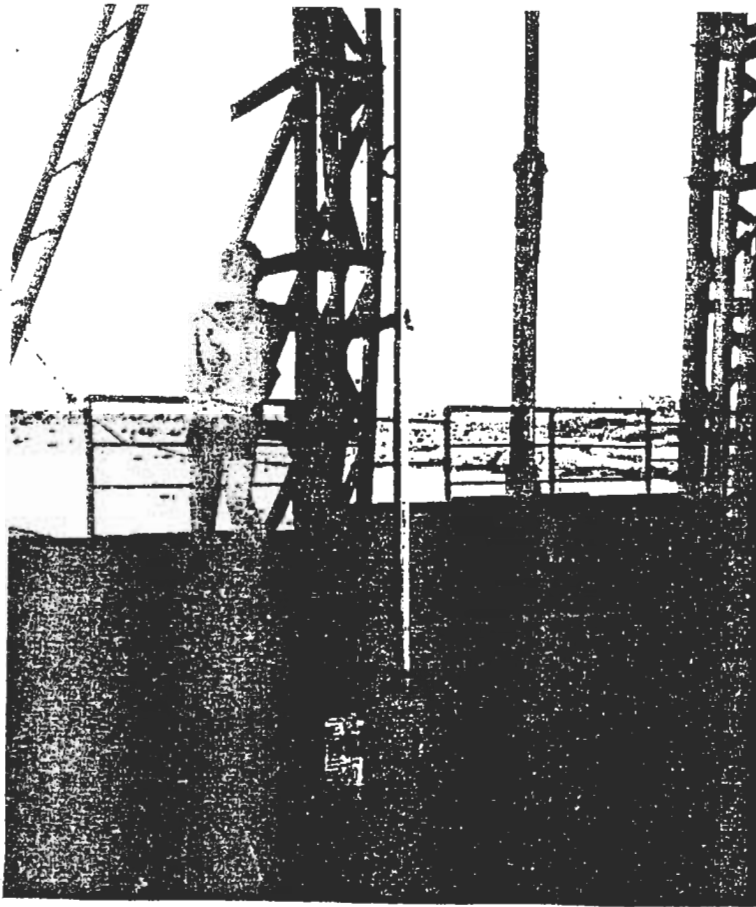
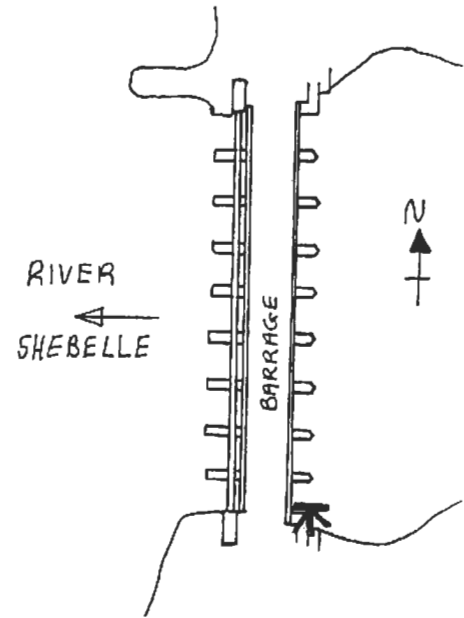
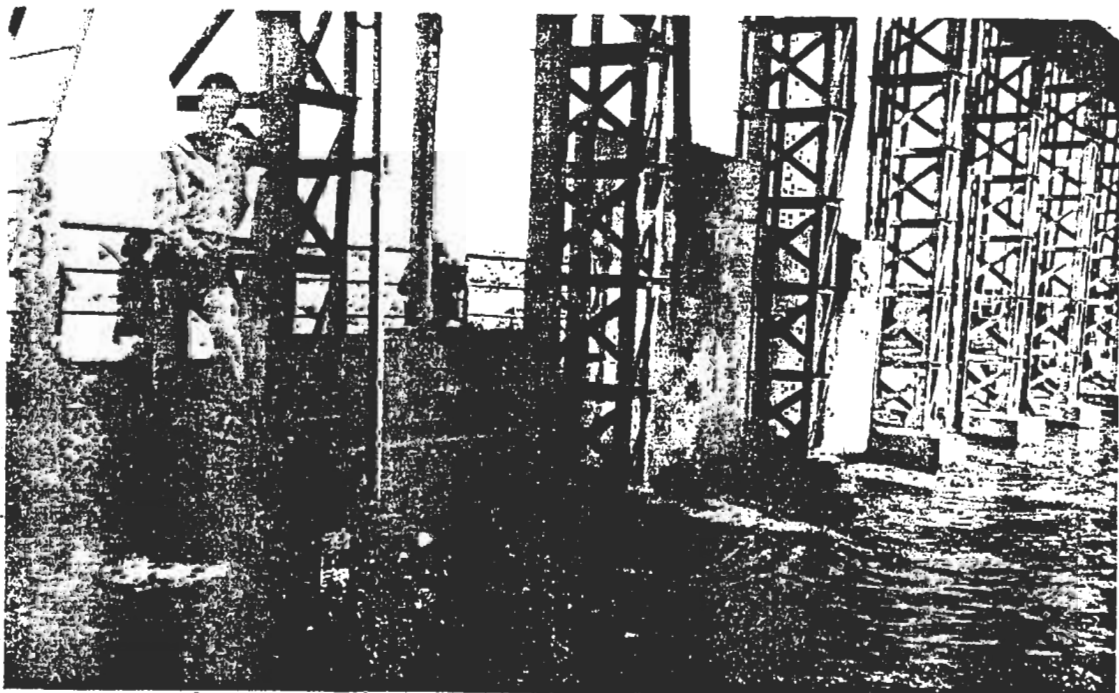
FUNDAMENTAL BM A65

ELEVATION 68.199

Qorioley Barrage

FBM A65 is on the north east corner of the upstream left bank concrete abutment.

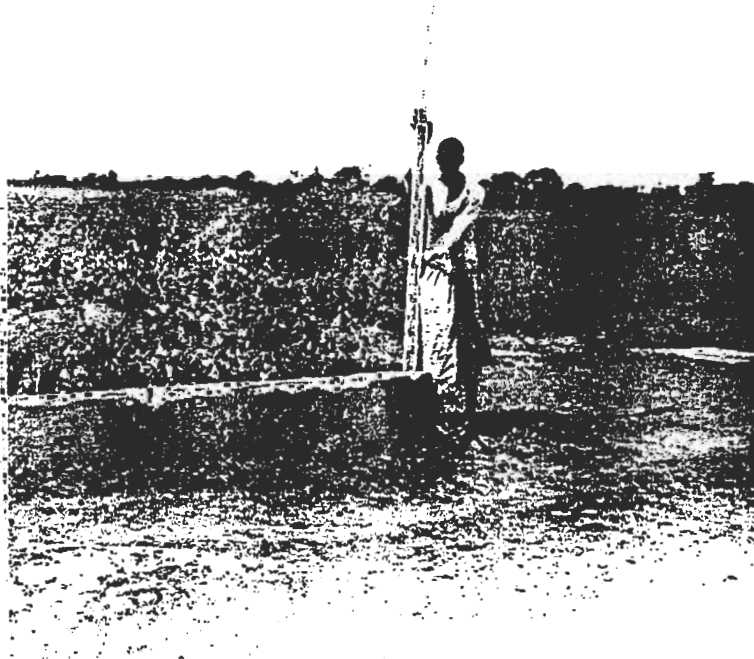
ELEVATION 66.209

BM 2 is on the centreline of the downstream culvert headwall at the western end.

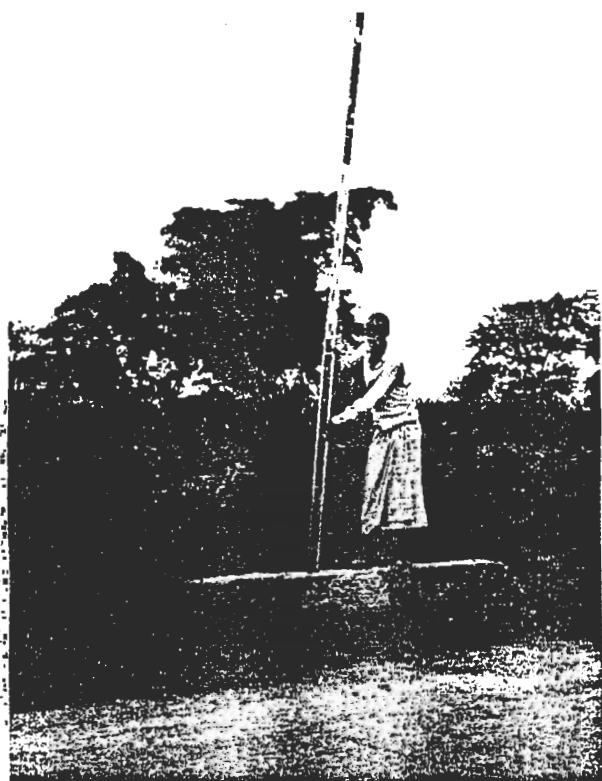
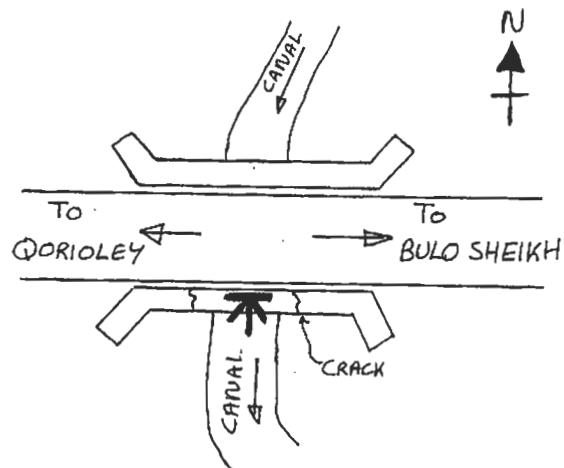
ELEVATION 66.465

BM 6 is on the centreline of the downstream culvert headwall at the centre between the two large cracks.

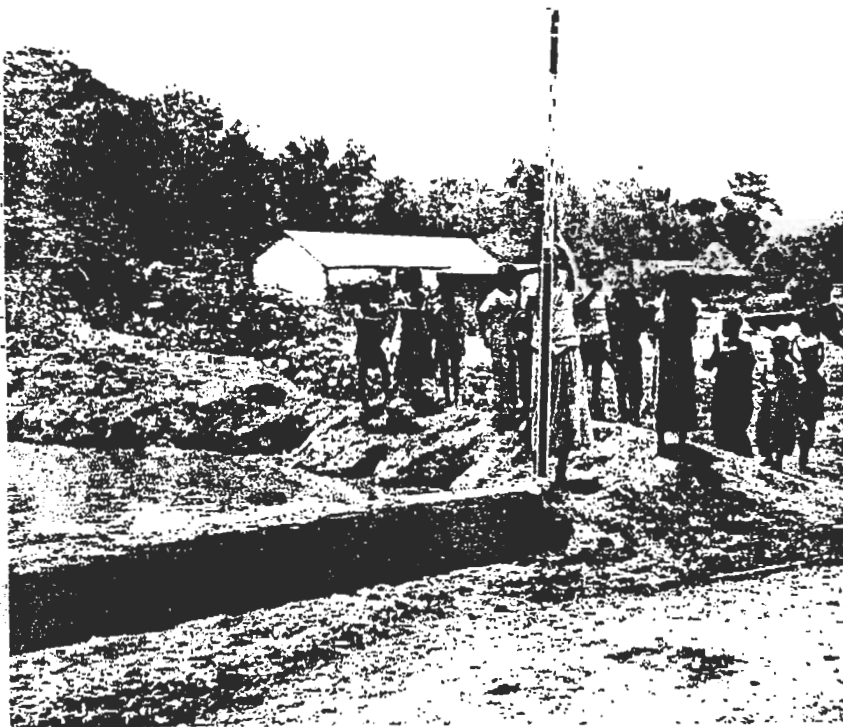
BM 8
ELEVATION 66.665

BM 8 is on the centreline of the downstream culvert headwall at the western end.

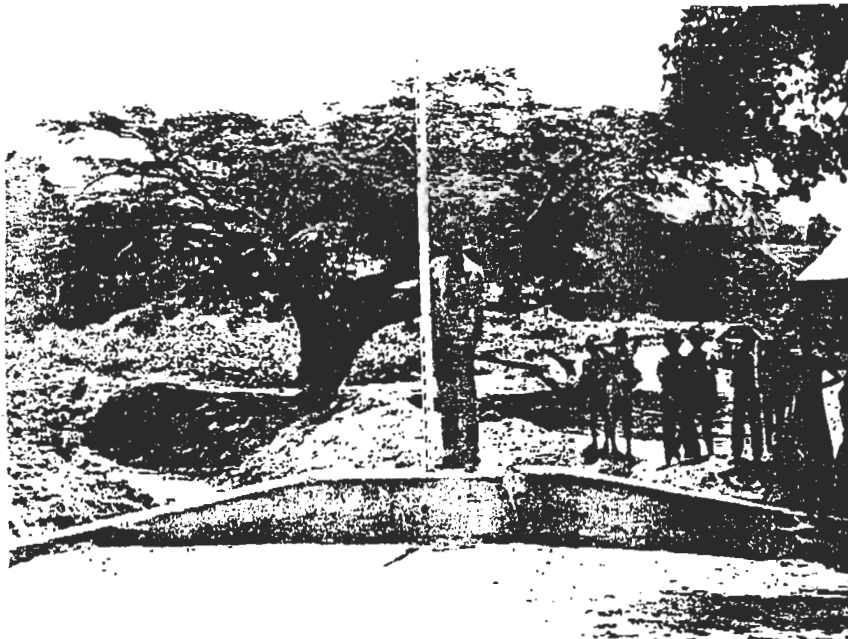
BM 9
ELEVATION 66.783

BM 9 is on the centreline of the downstream culvert headwall at the centre.

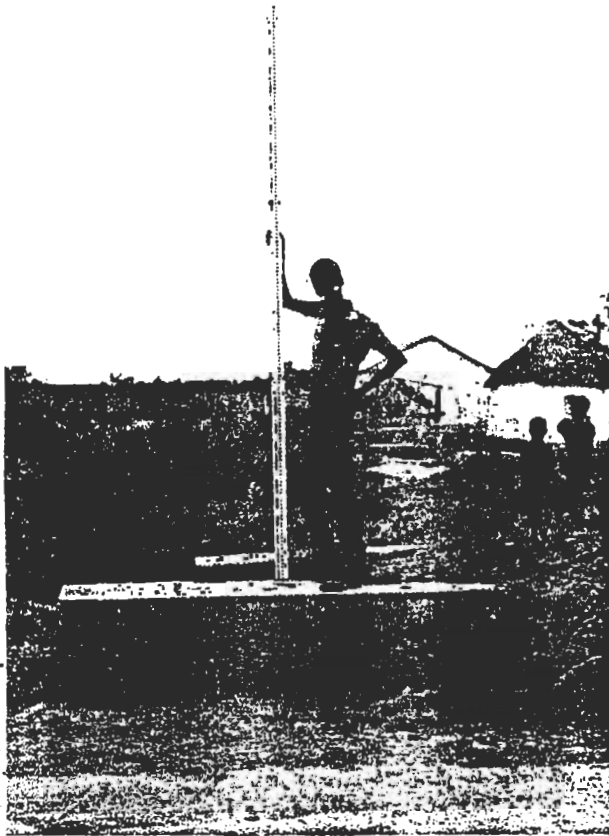
BM 10
 ELEVATION 66.434

BM 10 is on the downstream edge of the downstream culvert headwall at the centre.

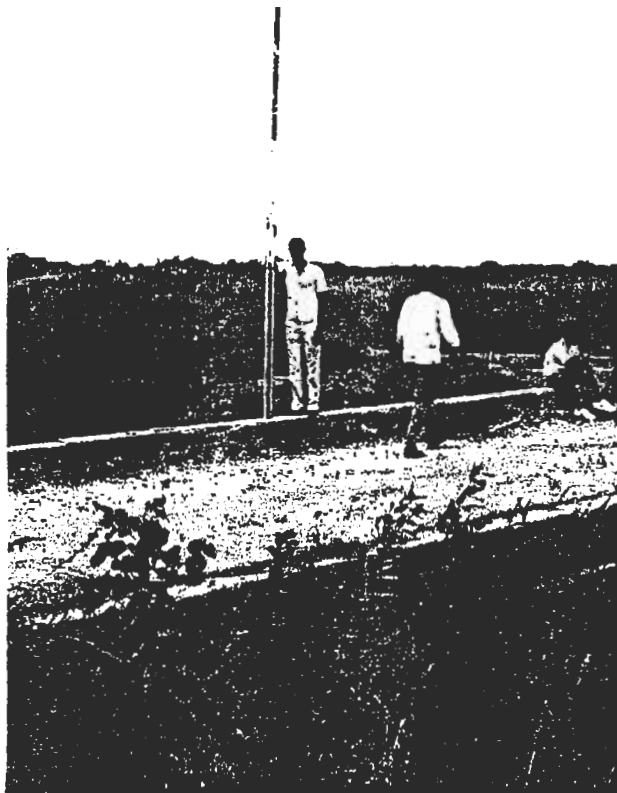
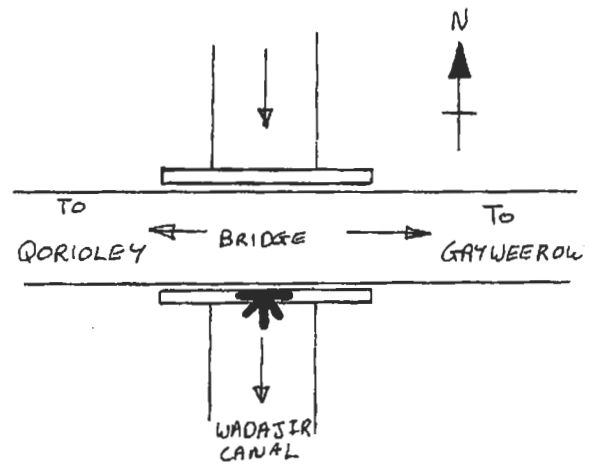
ELEVATION 68.941

BM 12 is on the centreline of the downstream bridge headwall at the centre.

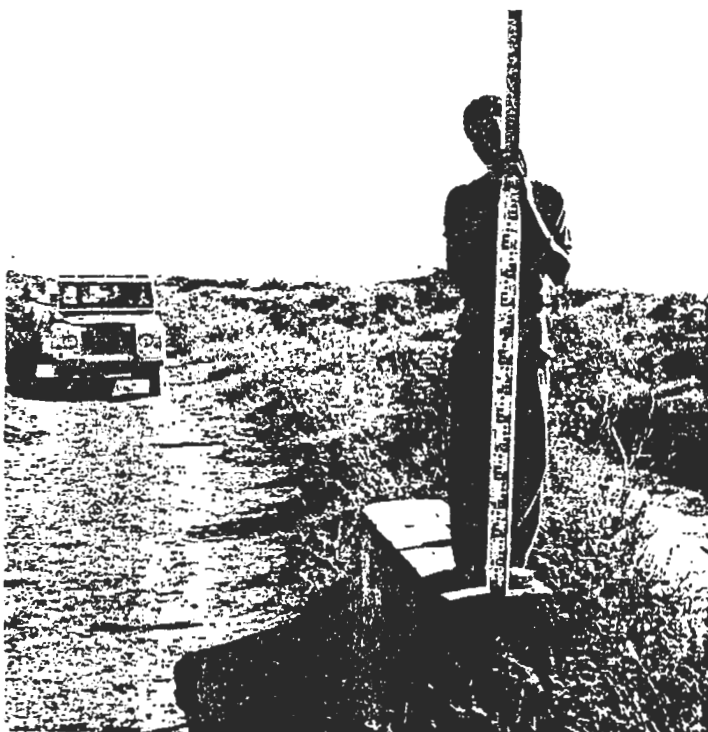
ELEVATION 68.937

BM 13 is on the centreline of the offtake headwall at the southern end.

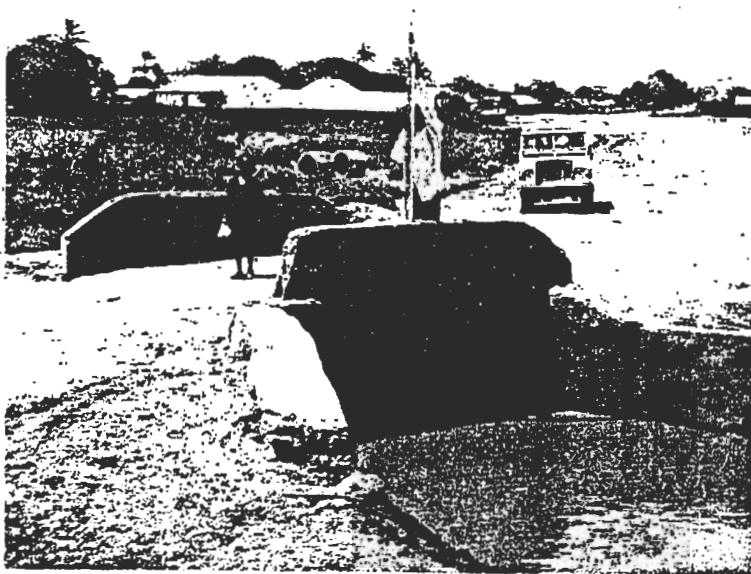
ELEVATION 67.164

BM 20 is on the centreline of the downstream culvert headwall at the centre.

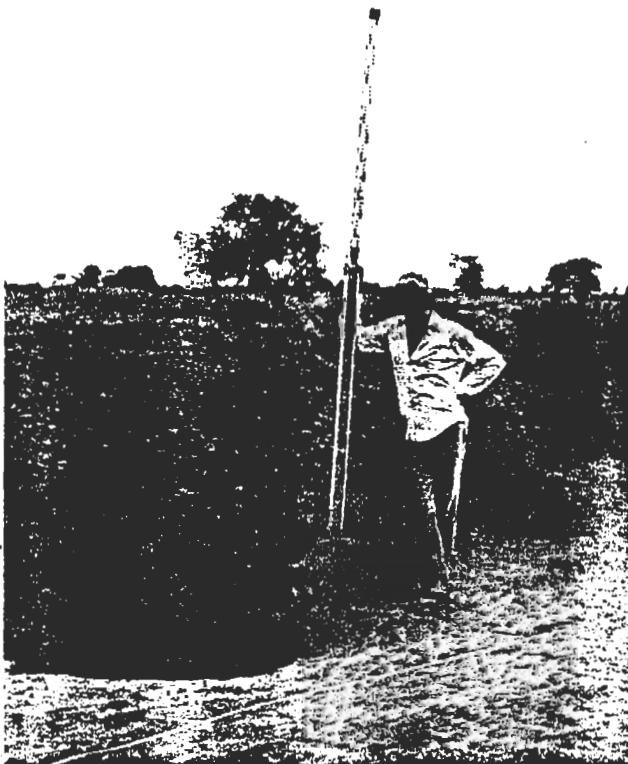
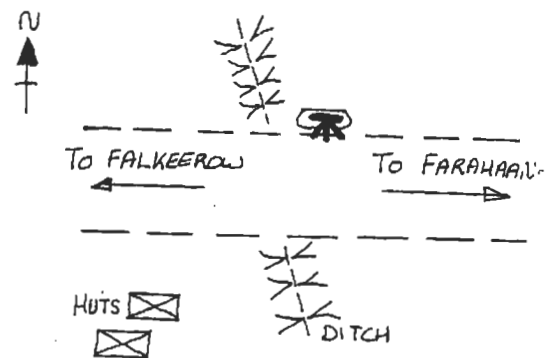
ELEVATION 65.845

BM 23 is on top of rock on north side of road which is a bit loose.

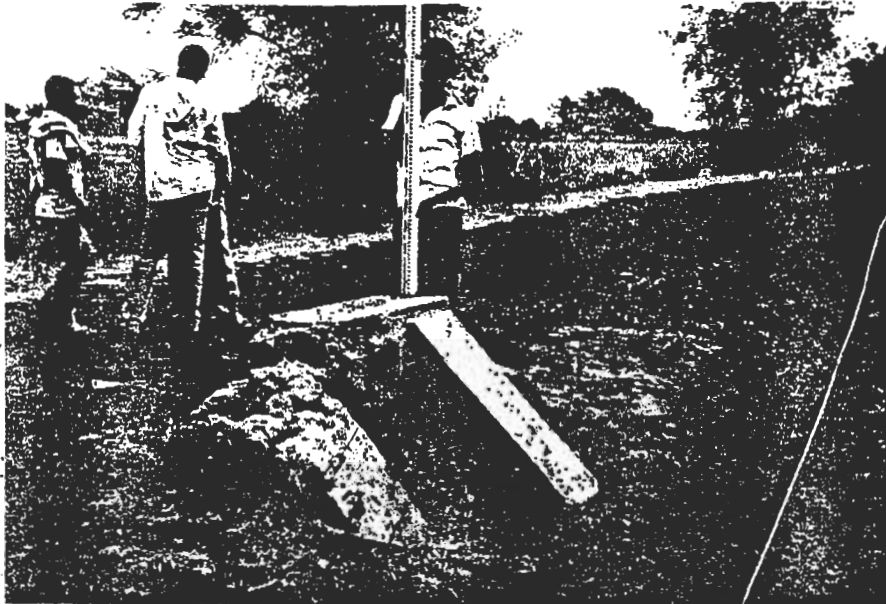
ELEVATION 64.832

BM 28 is on the centreline of the south disused road culvert headwall at the eastern edge.

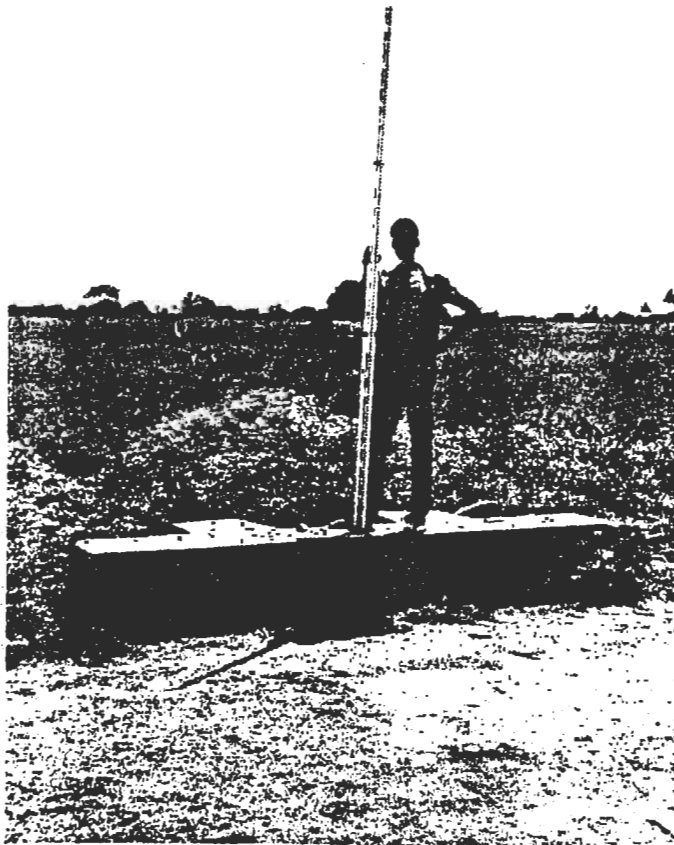
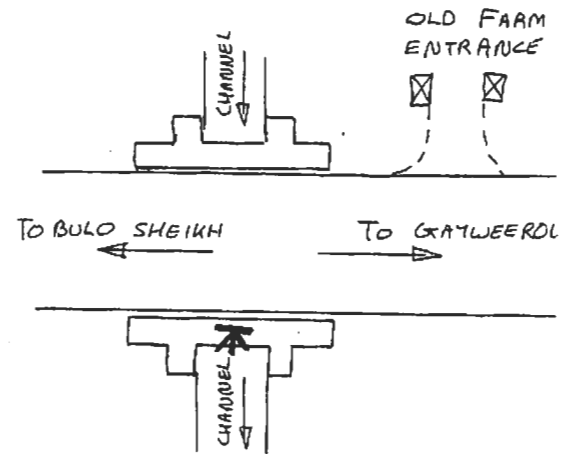
ELEVATION 66.713

BM 30 is on the centreline of the downstream culvert headwall at the centre.

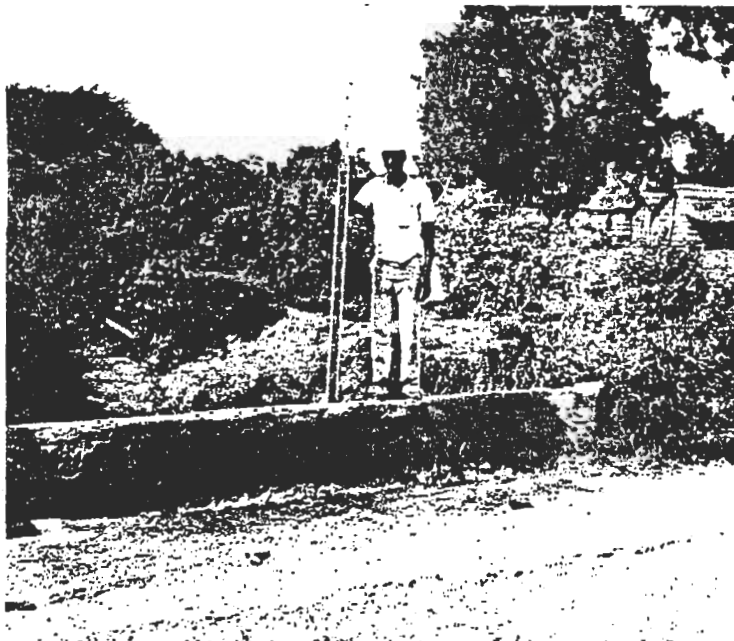
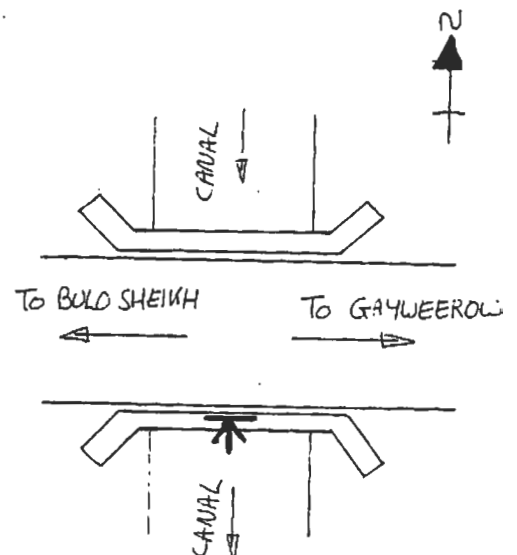
BM 33
 ELEVATION 69.471

BM 33 is on the centreline of the downstream culvert headwall at the centre.

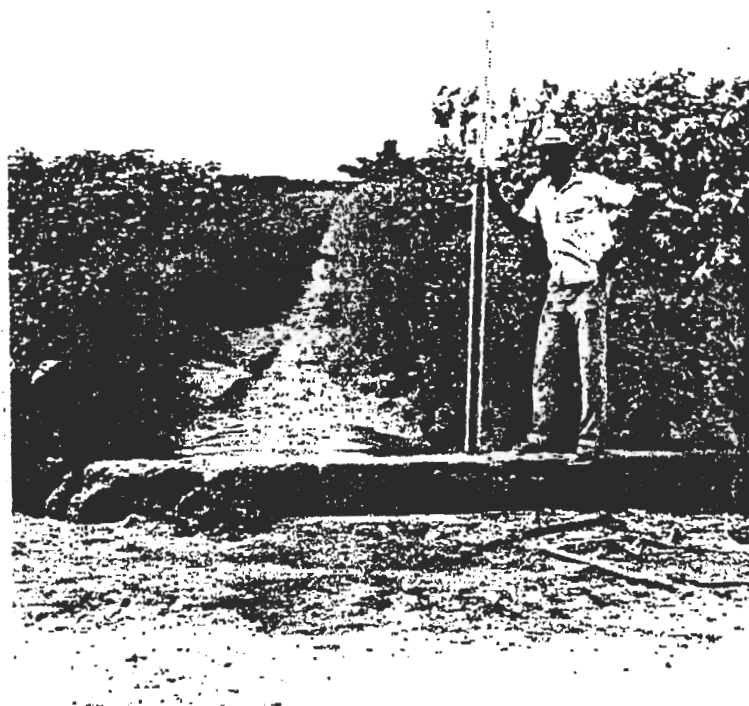
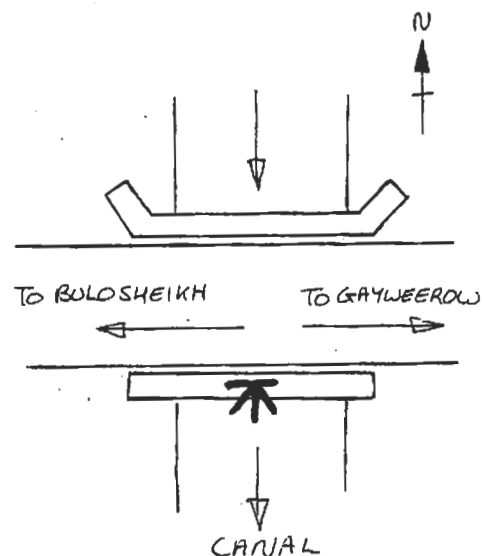
ELEVATION 69.249

BM 34 is on the centreline of the downstream culvert headwall on top of exposed metal loop.

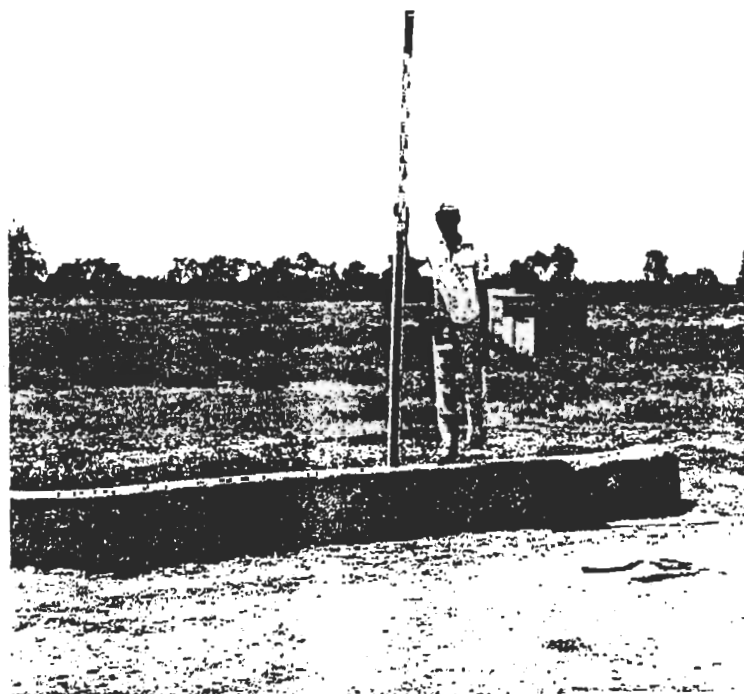
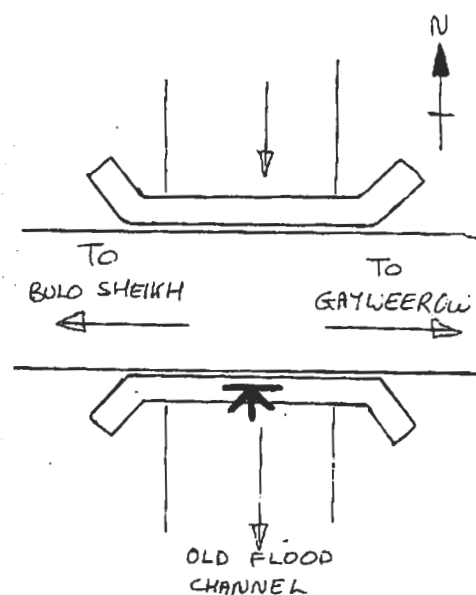
ELEVATION 69.835

BM 35 is on the centreline of the downstream culvert headwall at the centre.

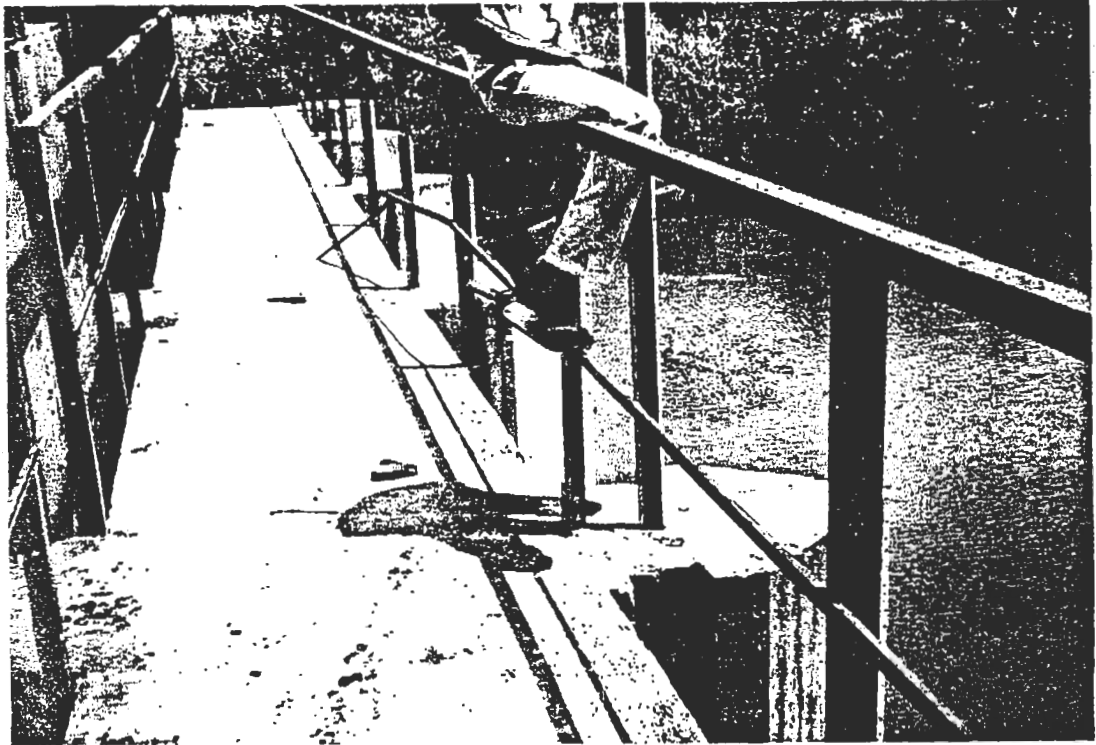
ELEVATION 70.649

Gayweerow Barrage
BM 37 is on the
centreline of the
middle upstream con-
crete pier between
the stop log grooves.

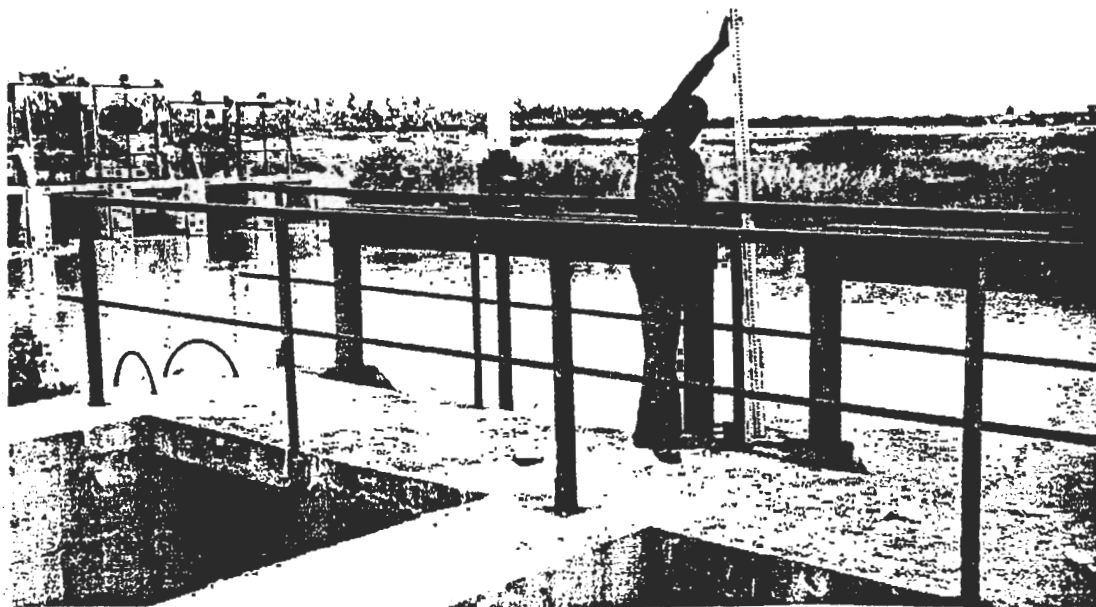
ELEVATION 71.352

Flood Relief Channel Headworks
 BM 38 is on the centreline of the middle upstream pier between the gates.

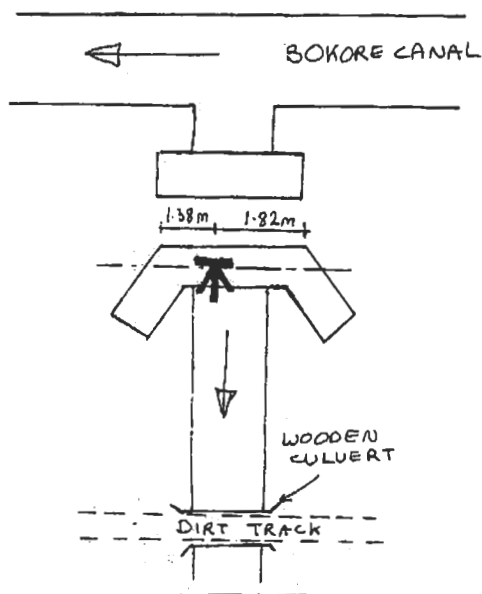
ELEVATION 66.693

BM 39 is on the centreline of the downstream head regulator headwall at 22 cm off-centre towards the right bank. The head regulator is 1 000 m from BM 27 measured along Bokore Canal.

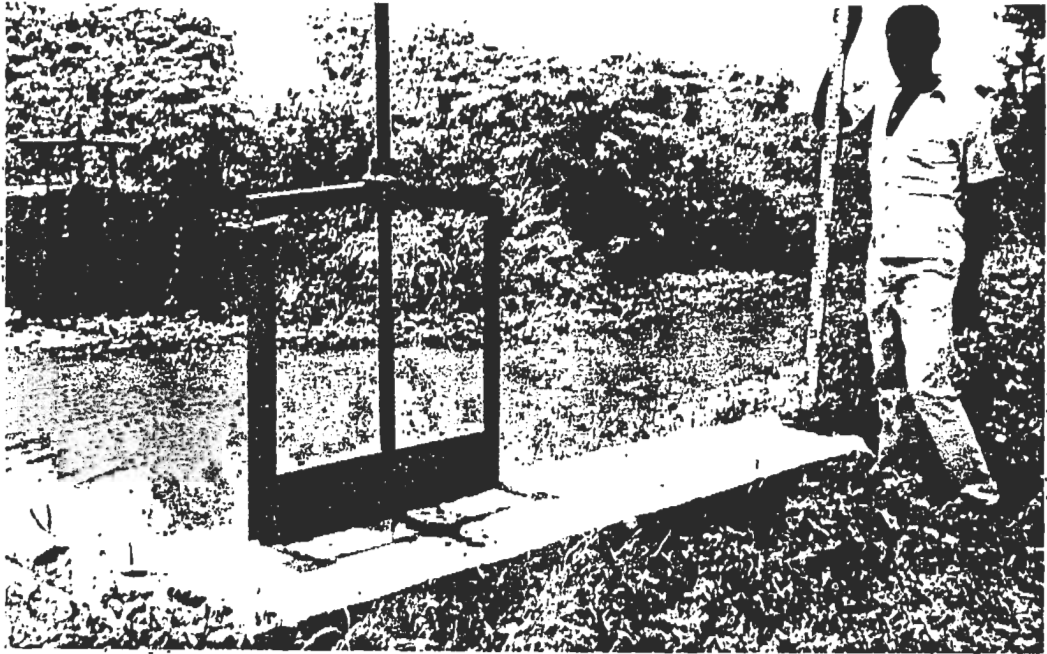
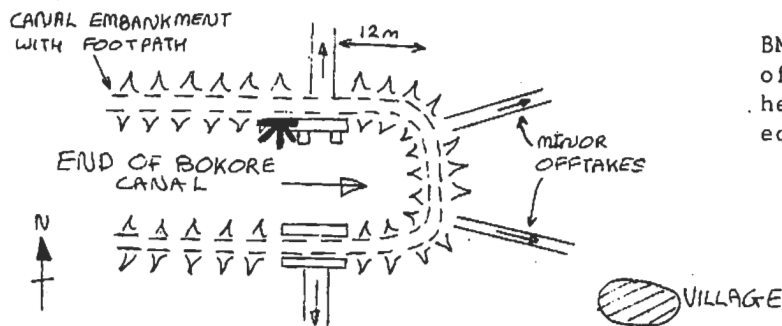
ELEVATION 65.633

BM 40 is on the centreline of the left bank offtake headwall at the western edge.

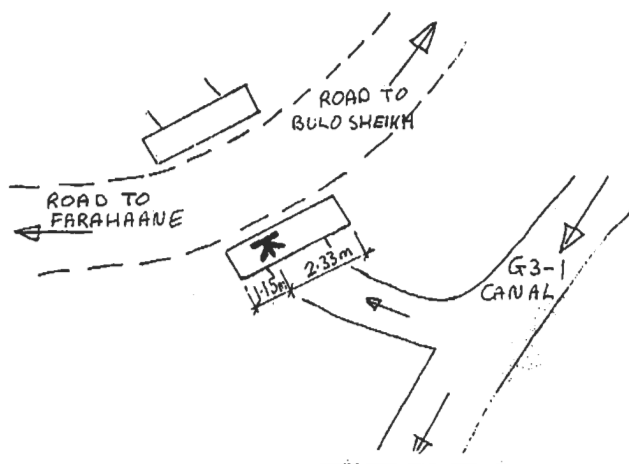
ELEVATION 64.976

BM 41 is on the centreline of the upstream road culvert headwall at 59 cm off-centre towards the left bank. The culvert is 2.75 km from Farahaane along the unsurfaced road to Bulu Sheikh on a 90° bend.

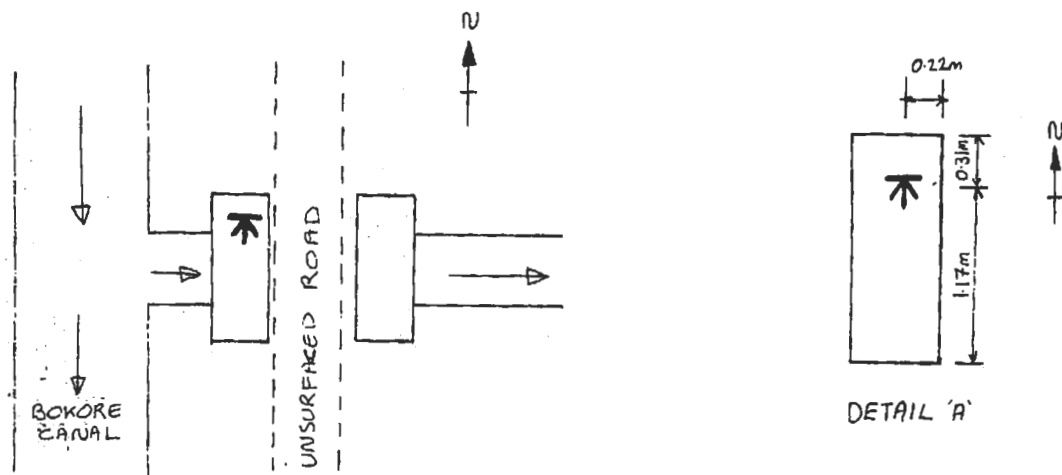
ELEVATION 64.942

BM 42 is on the upstream road culvert headwall as shown in detail 'A'. The culvert is at chainage 2.4 km south from BM 27 measured along the Bokore canal.

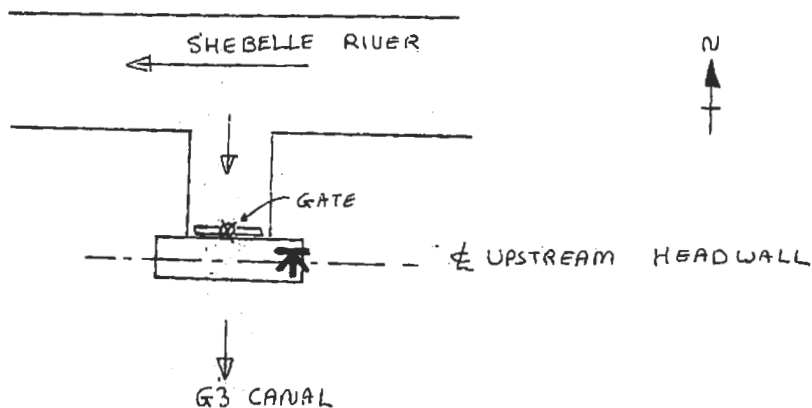
ELEVATION 68.559

BM 45 is on the centreline of the G3 canal head regulator upstream canal head regulator upstream concrete headwall at the eastern edge.

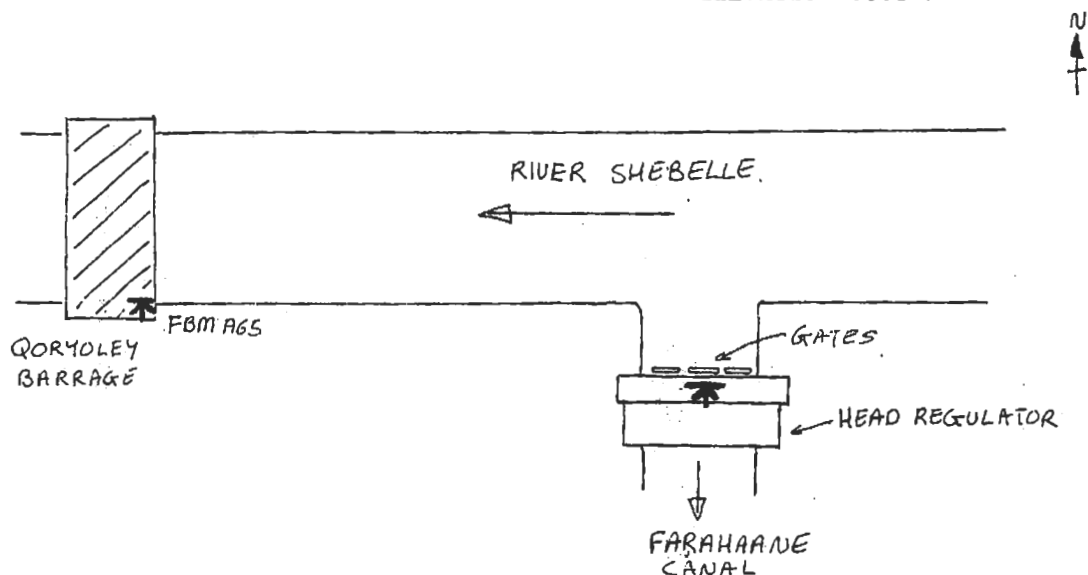
ELEVATION 68.071

BM 48 is on the centreline of the Farahaane canal head regulator upstream concrete headwall at the centre.

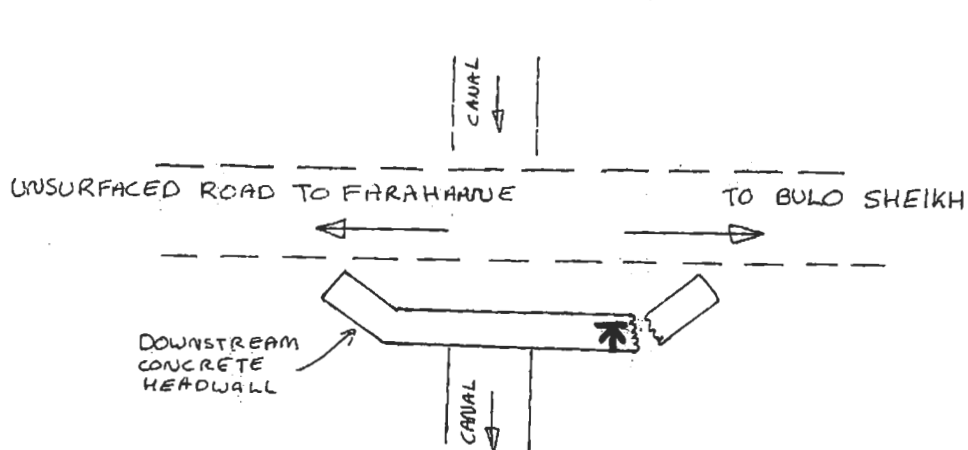
ELEVATION 65.683

BM 49 is on the centreline of the downstream road culvert headwall at the western side of the large crack. The road culvert is 1.7km from Farahaane village.

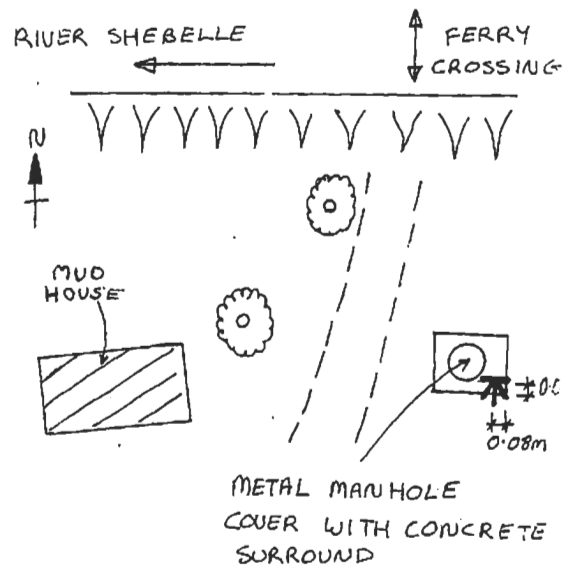
BM 51
 ELEVATION 67.145

BM 51 is on the south east corner of the concrete manhole surround near the river Shebelle in Haduman.

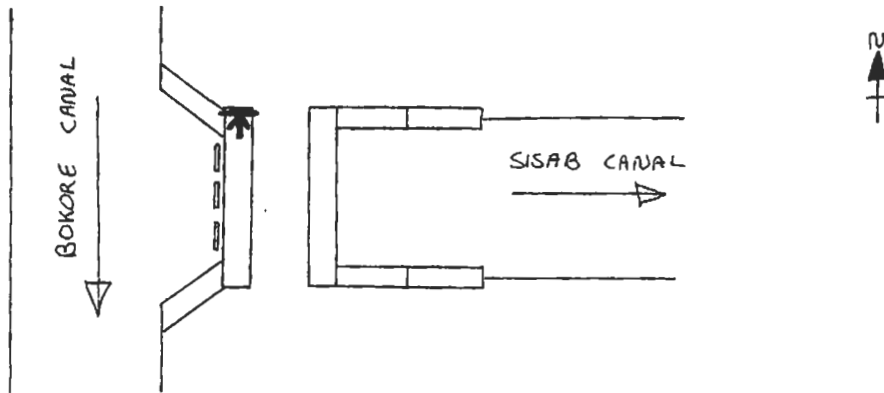
ELEVATION 67.055

BM 53 is on the centreline of the Sisab canal head regulator upstream headwall at the northern end.

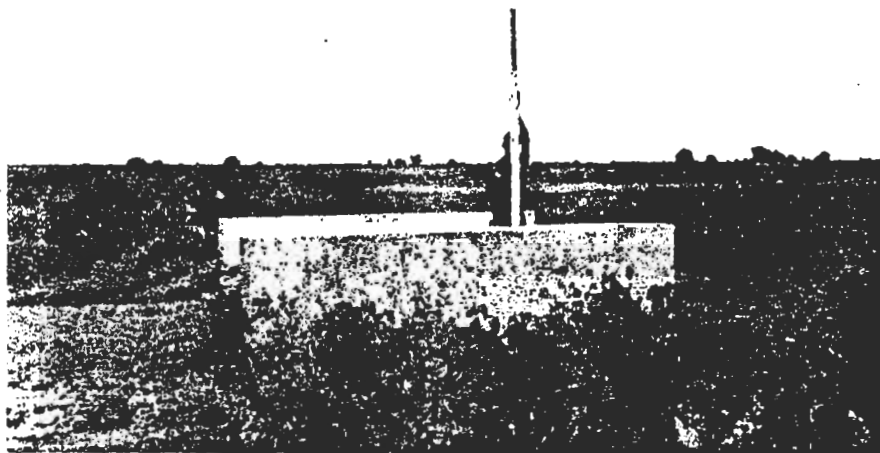
ELEVATION 66.371

BM 54 is on the centre-line of the upstream concrete headwall at 1.5 m from the northern edge.

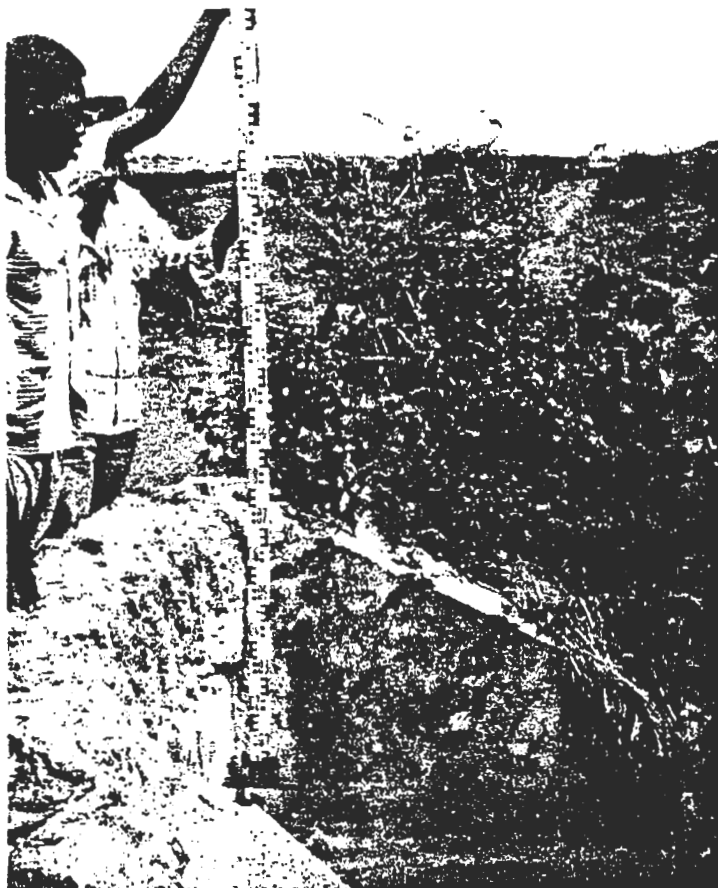
BM 55
 ELEVATION 66.495

ELEVATION OF UPSTREAM
 FACE OF OFFTAKE

BM 55 is on a ledge on the upstream face of the offtake headwall. The ledge is approximately 0.7 m below the top of the headwall at the northern side. The offtake is 1.7 km south of Madhulow.
