## Status of Medium to Large Irrigation Schemes in Southern Somalia

Technical Report No. W-05  
Oct 2007

Somalia Water and Land Information Management  
Ngecha Road, Lake View. P.O Box 30470-00100, Nairobi, Kenya  
Tel +254 020 4000300 - Fax +254 020 4000333,  
Email: [swalim@fao.org](mailto:swalim@fao.org) Website: <http://www.faoswalim.org>

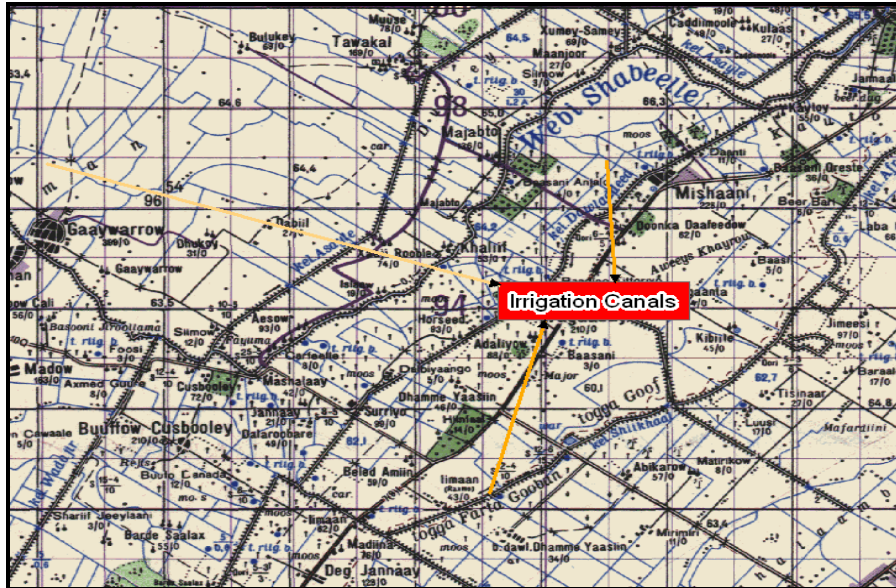
**Figure 5.1: Toposheet canals**

Irrigation infrastructure was digitized from scanned and georeferenced 1:100,000 topographic maps of Somalia, as shown in Figure 5.1 below. The maps were produced by stereo photography using aerial photography in the early 1970's. They were originally printed by the Bureau of Cartography, Ministry of Defense, Somalia Democratic Republic in the late 1970's, reprinted by Canadian Forces Mapping and Charting Establishment from reprographic material of native Somalia mapping by the British Director General of Military Survey. Revisions were made by the Defense Mapping Agency Hydrographic / Topographic Centre, Bethesda, MD, in cooperation with the Canadian Forces Mapping and Charting Establishment in the early 1990's.

Digitizing was originally done by the Regional Centre for Mapping Resources for Development RCMRD (2004). This dataset contained omissions and errors when checked against the topographic maps available at SWALIM. SWALIM, cross checked and re-coded the lines to correct the previous errors. Irrigation infrastructure that was omitted was re-digitized and topological errors such as overshoots and undershoots were also eliminated. These corrections were done only using topographic maps covering the irrigation areas of South and Central Somalia. Canals digitized from the topographic maps were considered to be baseline canals. Figure 5.1 shows a screenshot of the canals as shown on a topographic map sheet.

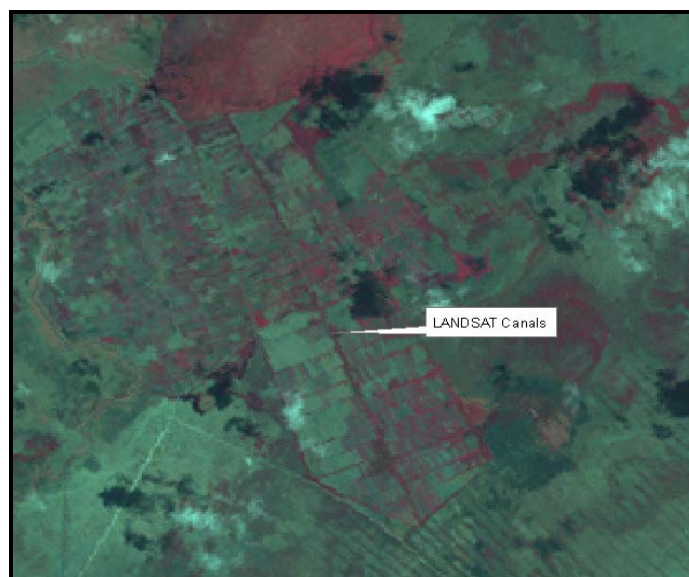
**Figure 5.2: Landsat imagery canal infrastructure**

New canals identified on the satellite imagery were added and classified as recent additions i.e. not found on the topographic maps. The study found out that, some new canals were developed in the 80s and 90s, while in some cases, the development of new canals was an improvement of the previous canal infrastructure. Figures 5.2 and 5.3 show canal infrastructure on satellite images.

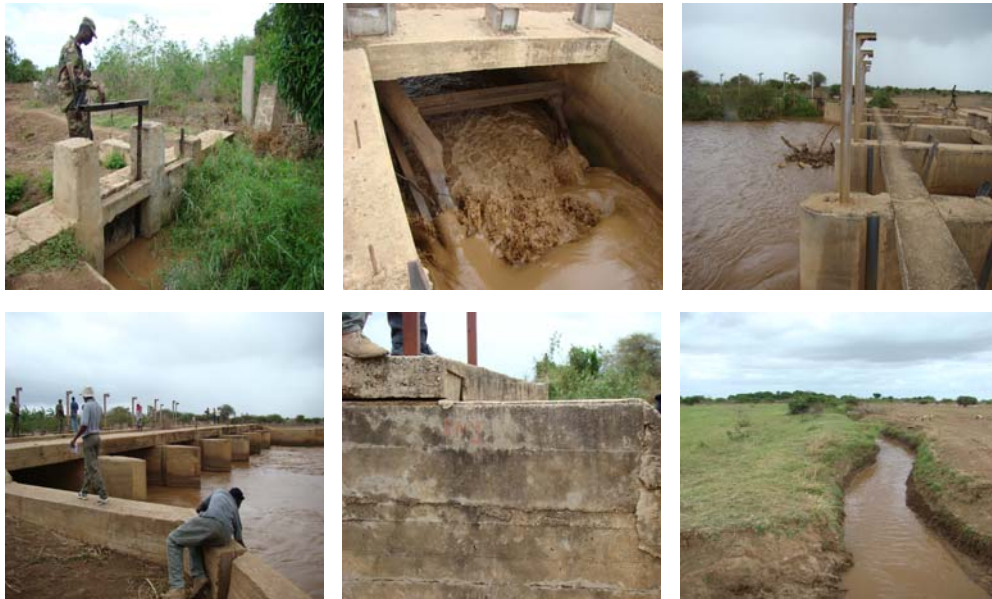
The Sabuun barrage has nine gates and all are stuck and embedded in mud, making it completely non-operational. The upstream of the barrage is blocked by tree trunks, silted up and overlaid by a thick layer of sediment blocking the inlets to the flood relief canal and the Jowhar off-stream supply canal. The gears are broken and the walk rails are missing as a result of vandalism after the break out of the civil war.

**Figure 6.1: Photos showing the current status of Sabuun barrage**

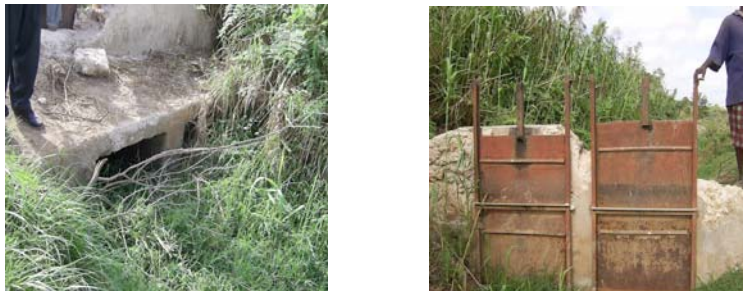
Three primary canals (Cessare Maria, Primo Secundario and Asayle) take water from Genale Barrage. All the three canals have direct offtakes to farms from the main channels. (Sir Mott McDonald and Partners Ltd, 1978; SWALIM database). The canals, according to SWALIM’s partner agencies, are currently partially operational and need desilting. Most of the regulators and off-takes are broken and in bad condition. Photographs taken from some of the canals are shown in Figure 6.2 below.

**Figure 6.2: Status of some of the canals taking off Genale barrages<sup>4</sup>**

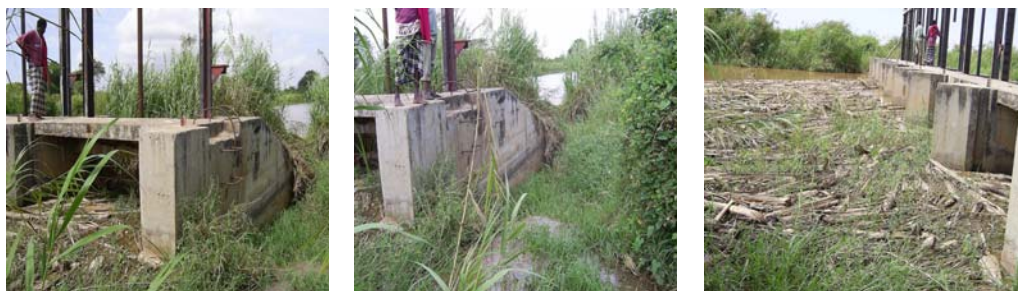
The majority of the canals around the barrage are non-functional since the barrage never operated.

**Figure 6.3: Current status of Mashalay barrage**

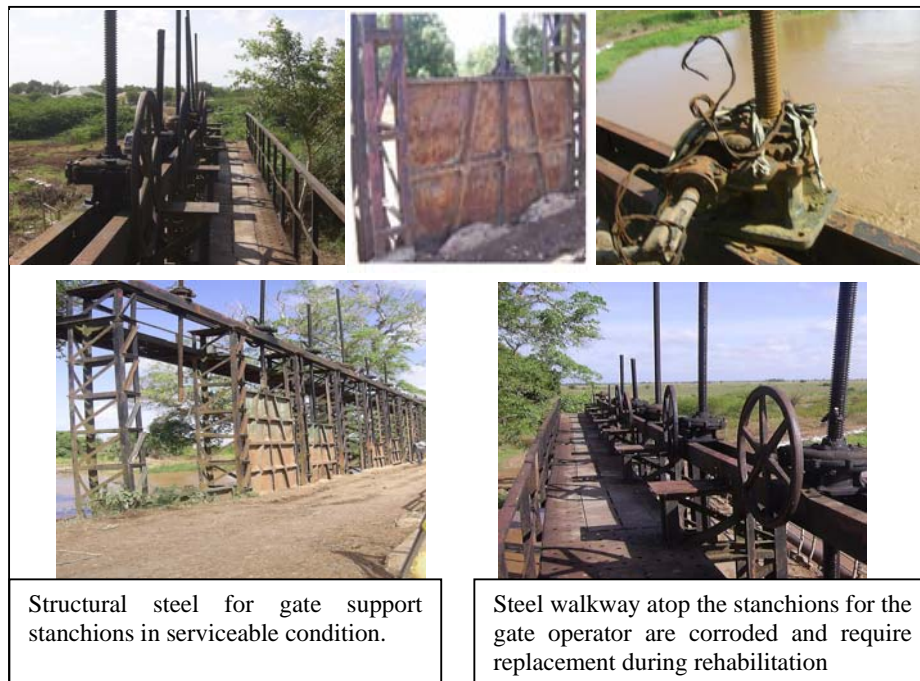
There are nine gates mounted in slides fixed into steel structural columns. The first and the last gates are smaller than the rest. The gates are made of thick mild steel plates and reinforced U-channels. The gate plates and reinforcements are heavily rusted and require to be replaced. The slides are either missing or worn out and all of them need to be replaced. The lifting mechanisms are comprised of main gear rack and pinion type, turning wheel connected to the main gear directly. Only one gear is functioning, with three others missing. The rest of the gears are defective, as shown in Figure 6.4.

**Figure 6.4: Status of gates, superstructure and lifting mechanisms in Qoryooley barrage**

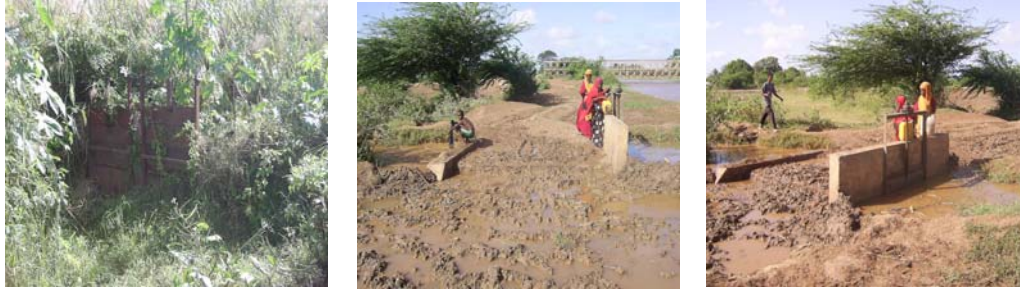
There are two primary canals that take water from the upstream of this barrage. These are: Fomari primary canal, which originates 8.2 km upstream of Qoryooley barrage with a command area of 2,890 ha, and Liban primary canal with a command area of 1,230 serving mainly Farahane irrigation project. The condition of these canals is best described by the photos in Figure 6.6 below.

**Figure 6.6: Status of some of the primary canals in Qoryooley barrage area**

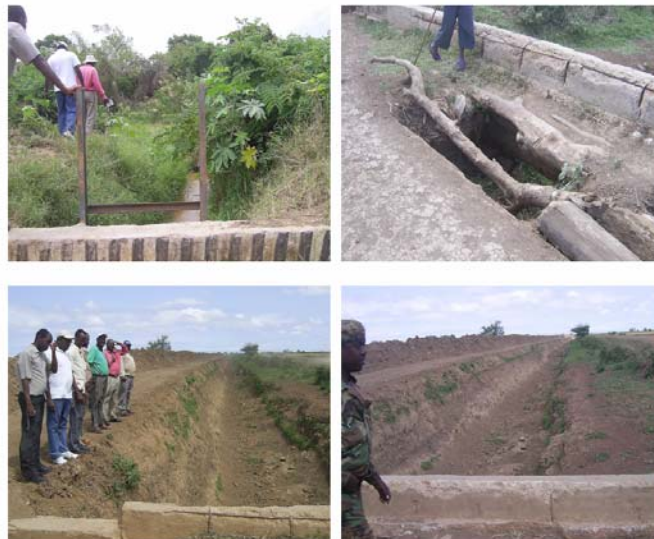
Three primary canals take off from the barrage. These are Bakooro, Furuqulay and Barwaqo. The canals provide water to the Farahaane Irrigation project. However, they are silted and overgrown by vegetation. Bakooro is currently under rehabilitation by FAO and CEFA, but the other two remain in bad state. The heavy siltation, vegetation and malfunctioning off-take structure greatly affect the efficiency of the canals.

**Figure 6.8: Status of primary canals taking off Falkerow barrage<sup>5</sup>**

<sup>5</sup> The top left photo show Furuqulay canal overgrown by vegetation with no gates and regulators, while the other photos show the Bakooro canal under desilting by FAO/CEFA. There is clear evidence of damage in cross regulators

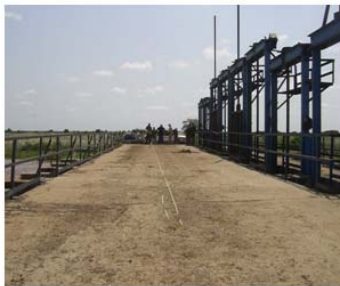
The main barrage deck and structure are generally in good condition. The barrage deck slab is also in reasonably good condition except for some worn out sections on the top of the slab and the edges where the reinforcement steel is exposed, Figure 6.9.

*The Barrage deck slab in relatively good condition*

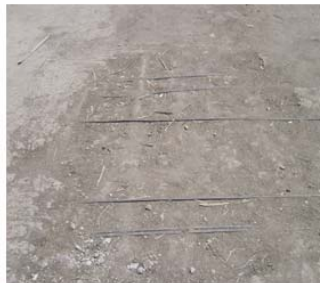
*Parts of Barrage deck slab with Exposed Reinforcement steel*

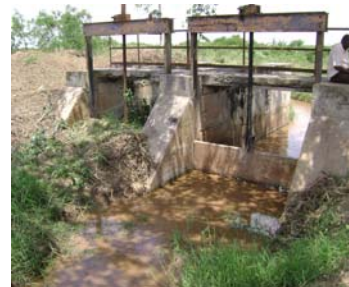
*The off take structure of canal no 5 is in good condition but concrete is broken on the underside exposing the steel reinforcement, no gates and lifting mechanisms*

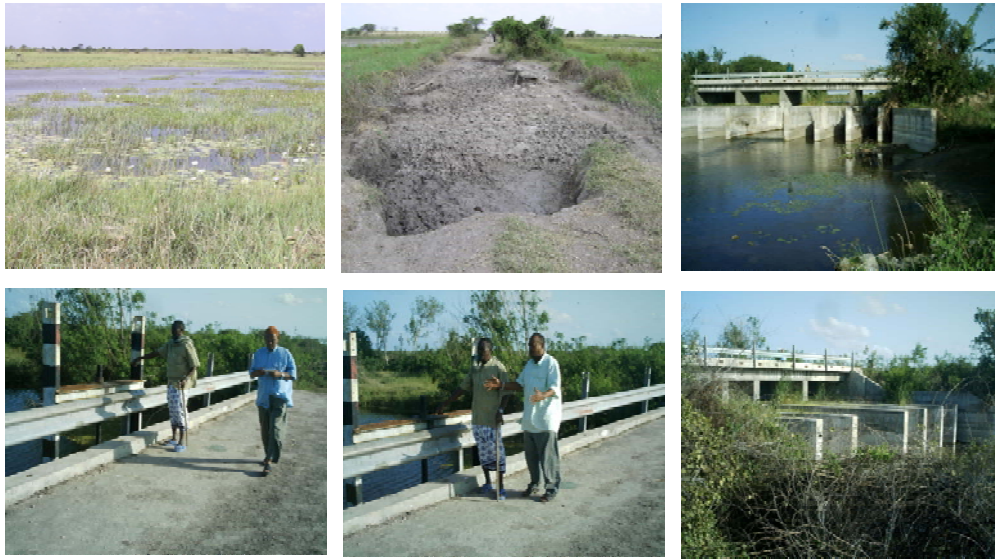
- A lot of water is flowing outside the barrage point
- The villagers have been cut off and use boats/canoes to get to their homes
- Continuous water flow this direction will result in swamp water level going down to a point that canals served by this barrage will not receive any water.
- The swamp both upstream and down stream is extending rapidly and will soon eat into the arable land
- The irrigation canals are of poor conditions.

**Figure 6.11: Snap shots from Sablale barrage<sup>6</sup>**

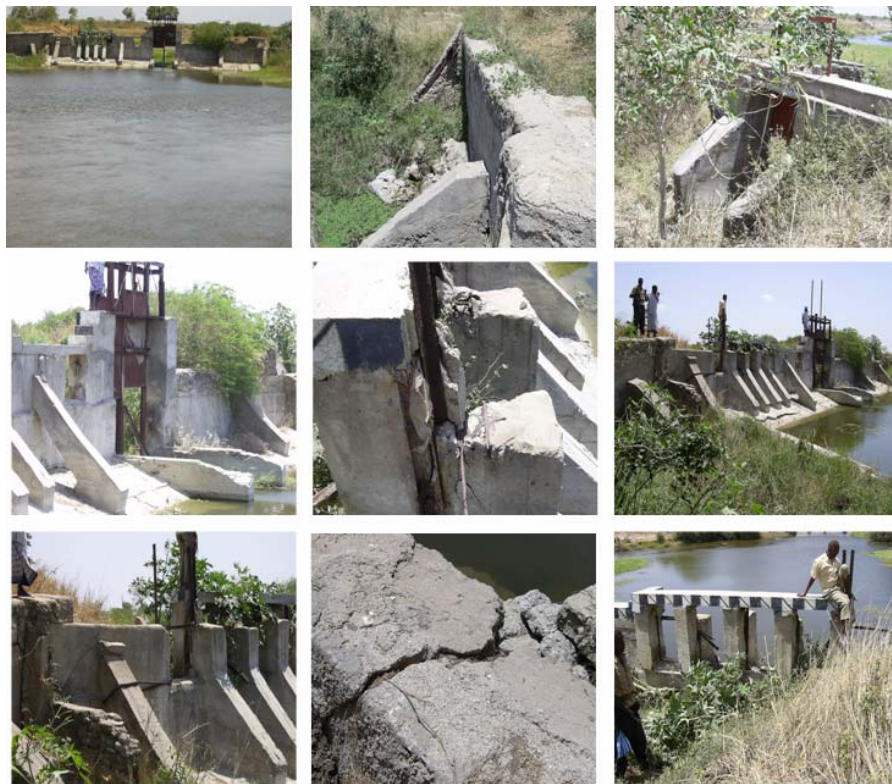
The weir is hanging with all the foundations breached. The superstructure consisting of concrete, form work, hardcore fill and scour sluices are all broken and need fills and a new river course diversion.

**Figure 6.12: Current status of Haway barrage and its canalization system**
