Lower Juba River Breakages. Lower Juba Region

WV2 Images (Dec 2012 - Aug 2014)

Map Reference: WAT-BREAKAGES-JUBA-2014-20141016-A0-002
Map Produced by: The Somalia Water and Land Information Management Project (SWALIM).
SWALIM is implemented by the United Nation's Food & Agriculture Organization
and is funded by the European Commission with co-funding provided by UNICEF.

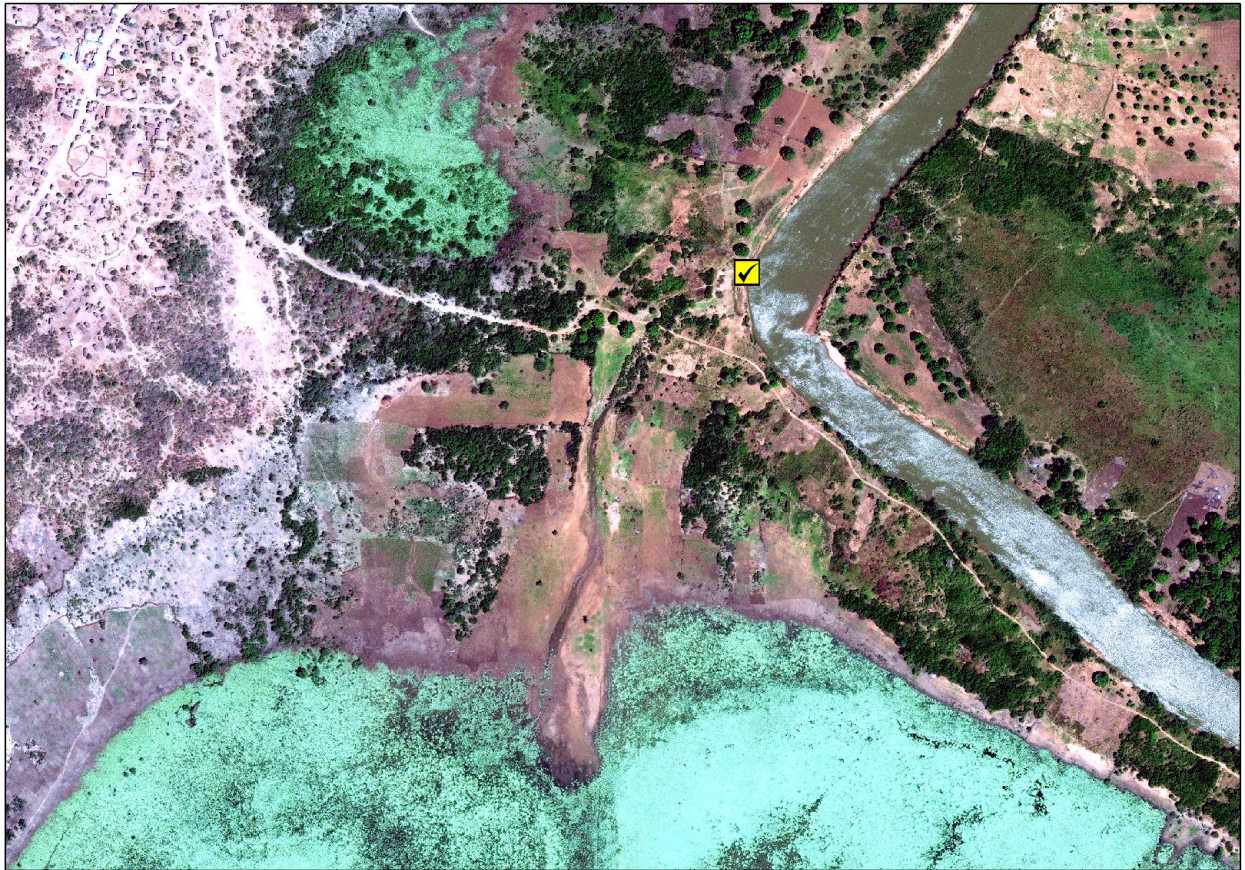
Raxoole (3 Feb 12) - In Feb 2012 signs of a flood are evident. Water spillage may have taken place from this point. The lack of embankments make this point vulnerable.

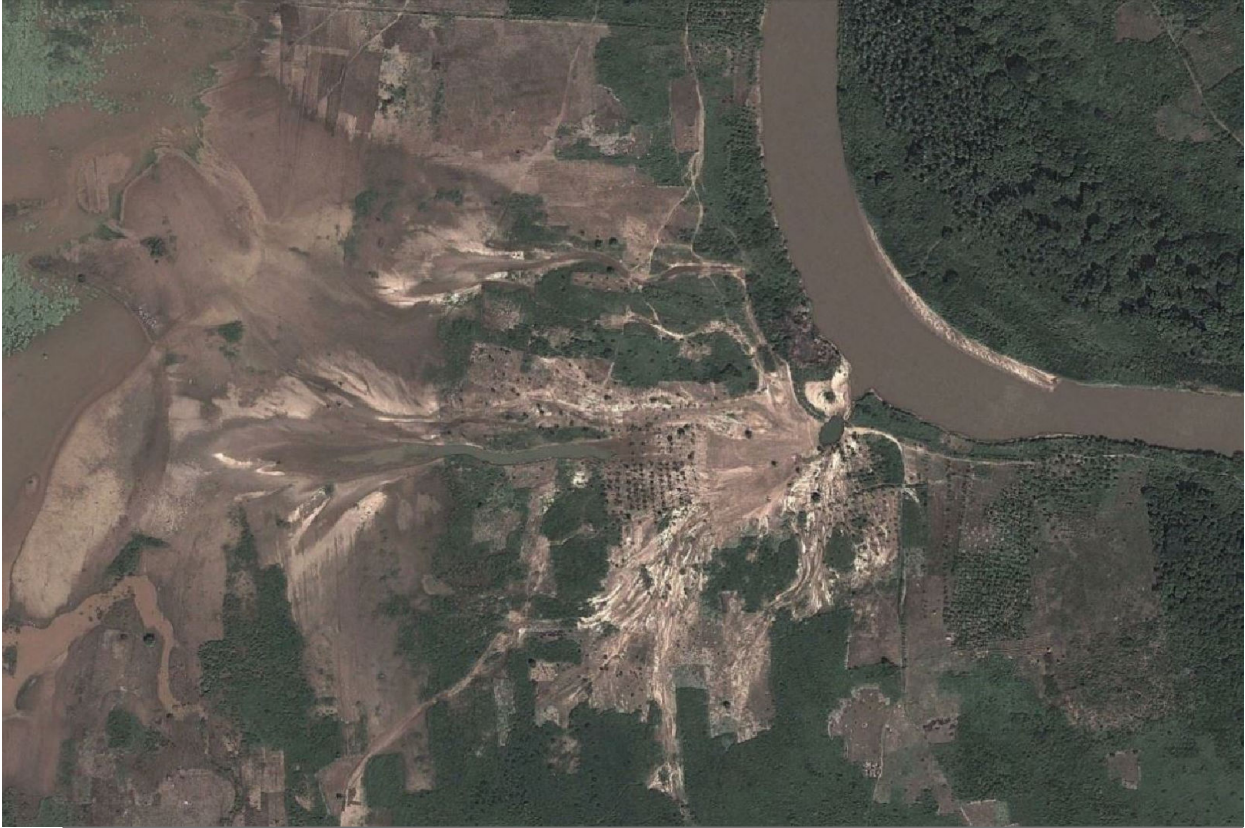
Cusmaan (1st Jan 14) - In 2012 and 2013 presence of sediments indicate that overflows occurred from this point. In late 2013 a major flooding occurred but no mitigation measures (embankments) are noticed as of March 2014. DEM and previous reports confirm this vulnerability.

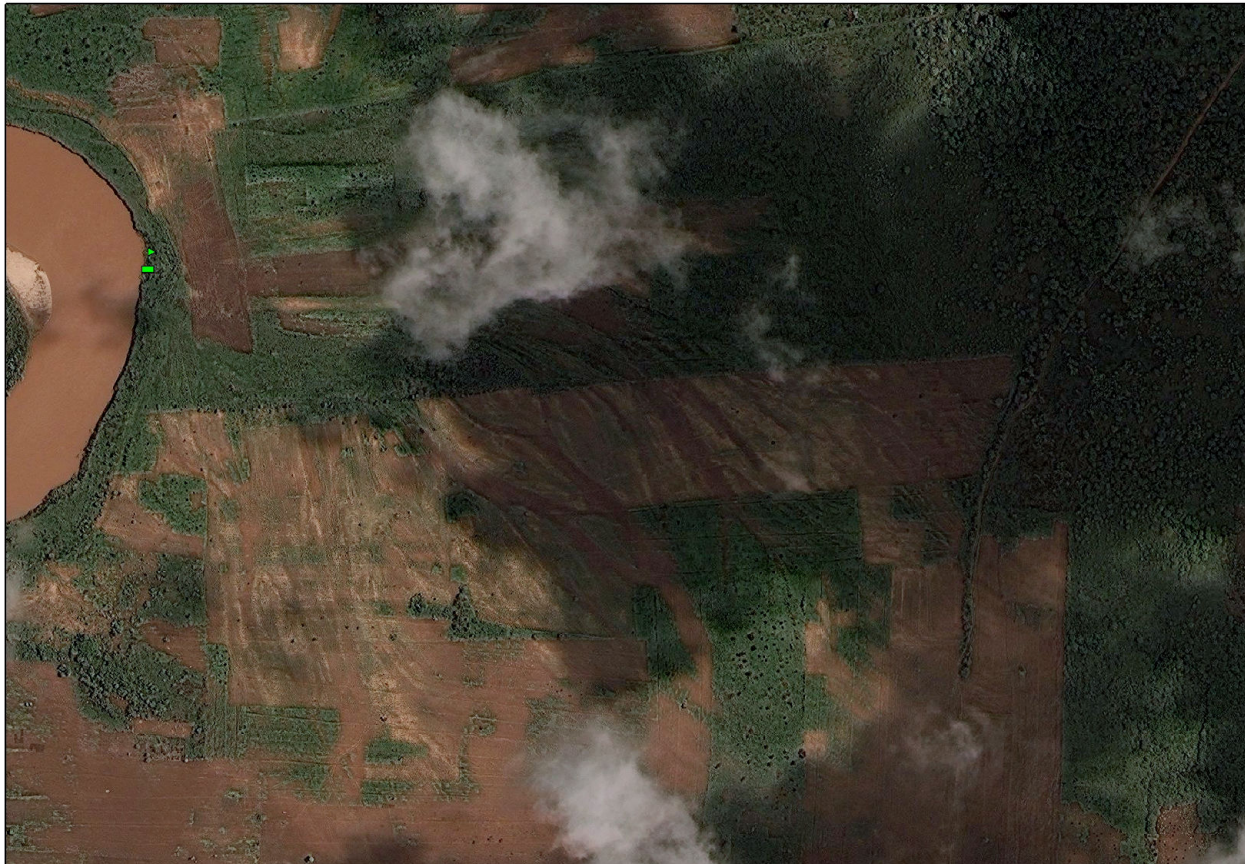
Seylac (24 May 14) - The image of Jan 2012 clearly shows that a breakage was present in this point. In late 2011 and a huge flooding took place. In 2013 and 2014 the breakage is closed. In May 2014 the area is flooded but the spillage is not coming from this point.

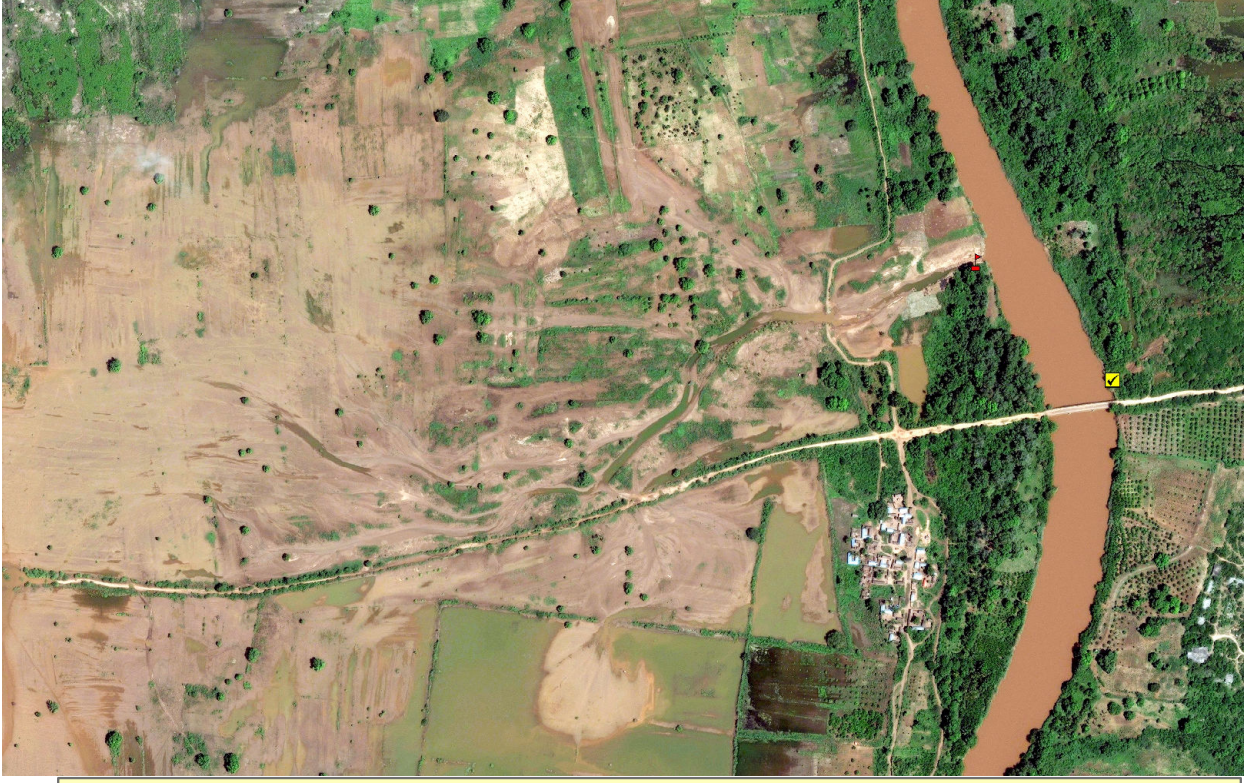
Muuna (18 Dec 13) - In Nov 2013 there is evidence of an active breakage at this point causing a major flooding. DEM and image of 2012 shows vulnerability. Images of 2014 show a minor fixing of the breakage, so it is still considered potentially vulnerable.

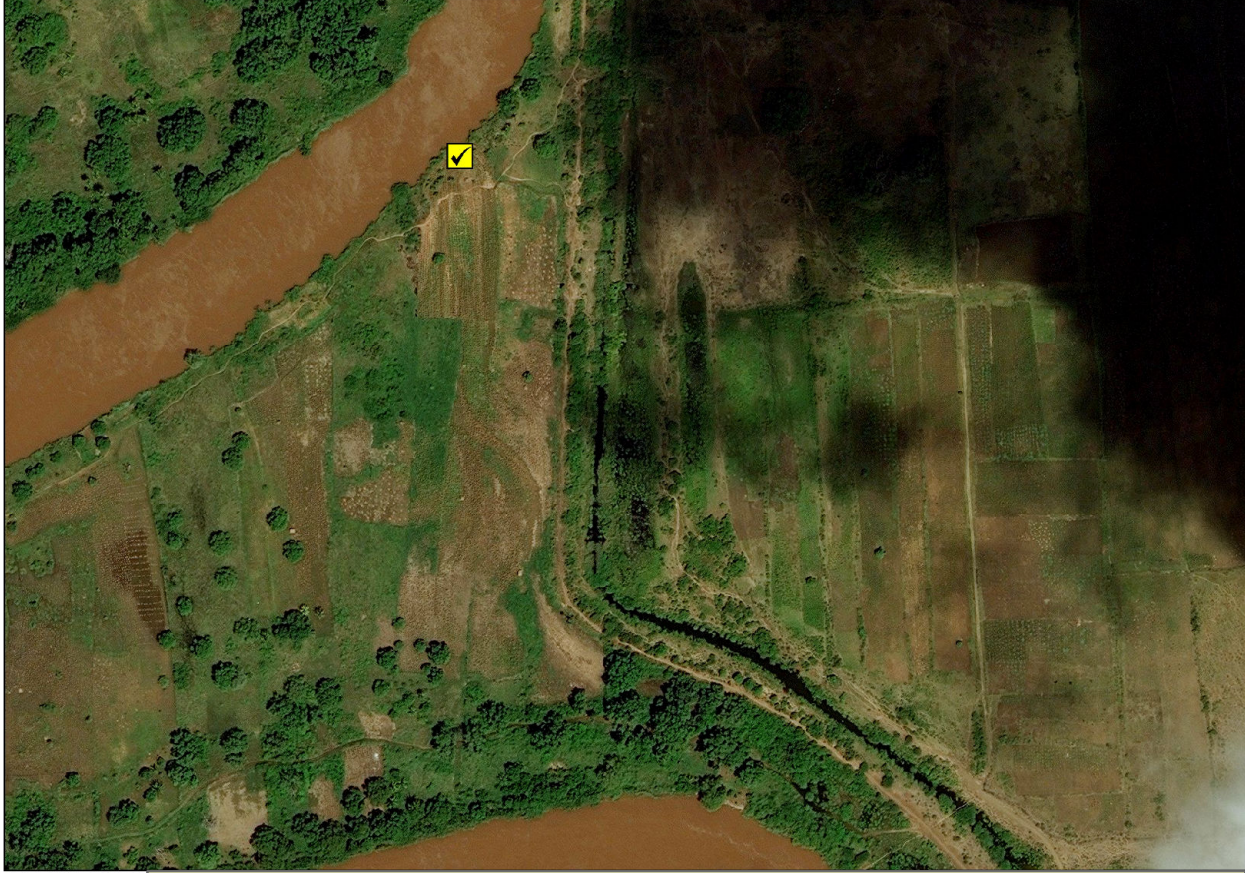
Mubaarak (14 Sept 13) - The images of 2012 and 2013 shows signs of an old flooding branching from this point. DEM confirms vulnerability.

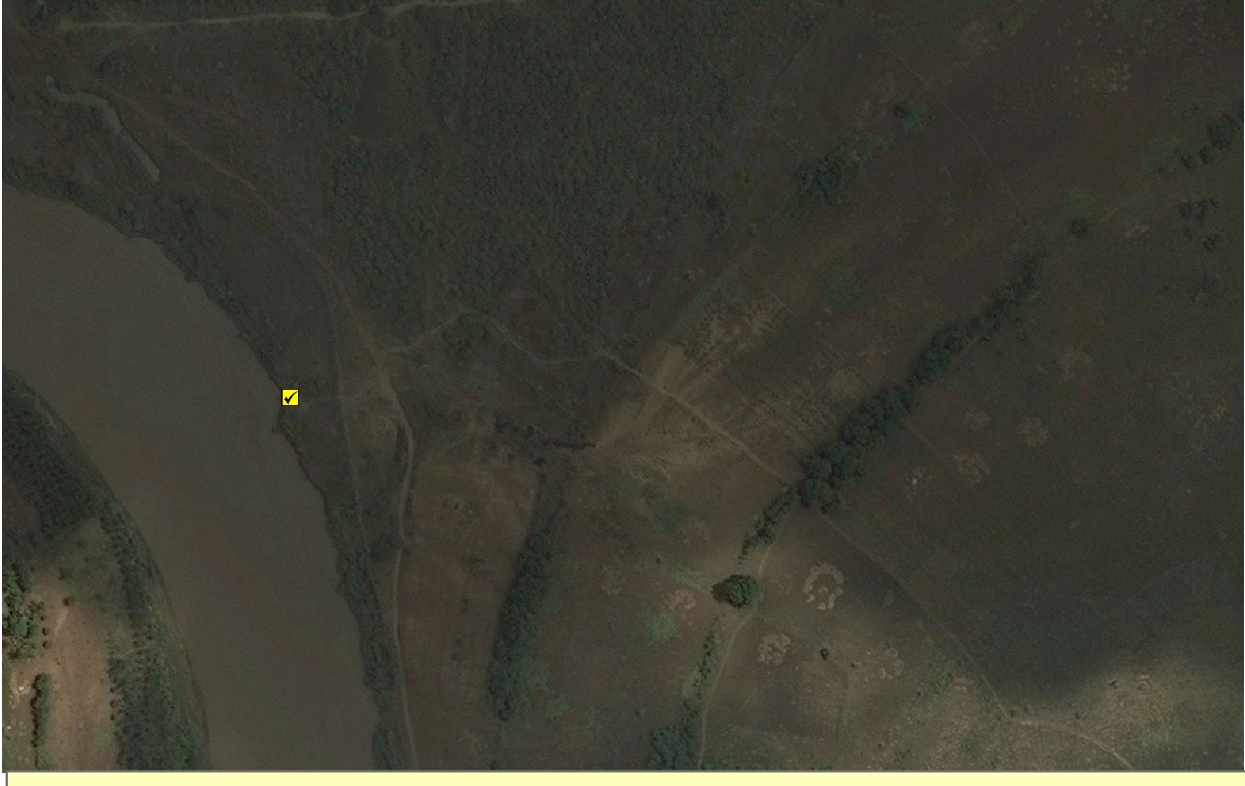
Sciongolo Dunia (30th Aug 14) - In 2012 a breakage was present, producing a major flooding. The image of 2013 is covered by clouds. In Jan 2014 the breakage is visible and seems to be opened. In May and Aug. 2014 signs of flooding are detected but the breakage seems to be closed.

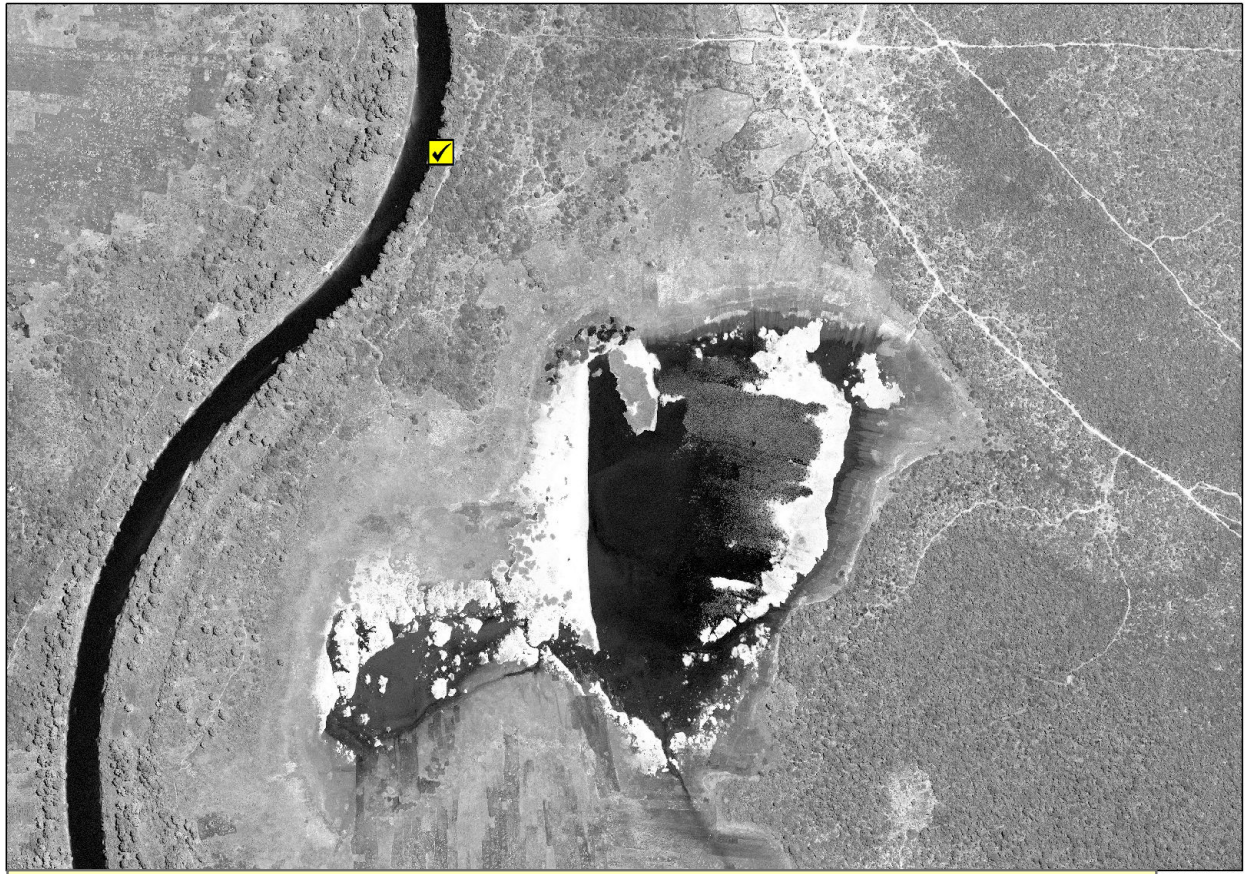
Mashane (13 Feb 13) - The analysis of 2012 shows there is a water overflow spreading from this area and causing a serious flooding. DEM confirm this observation. In 2013 are still visible signs of 2012 flooding while in 2014 a new flooding occurred. Very vulnerable area.

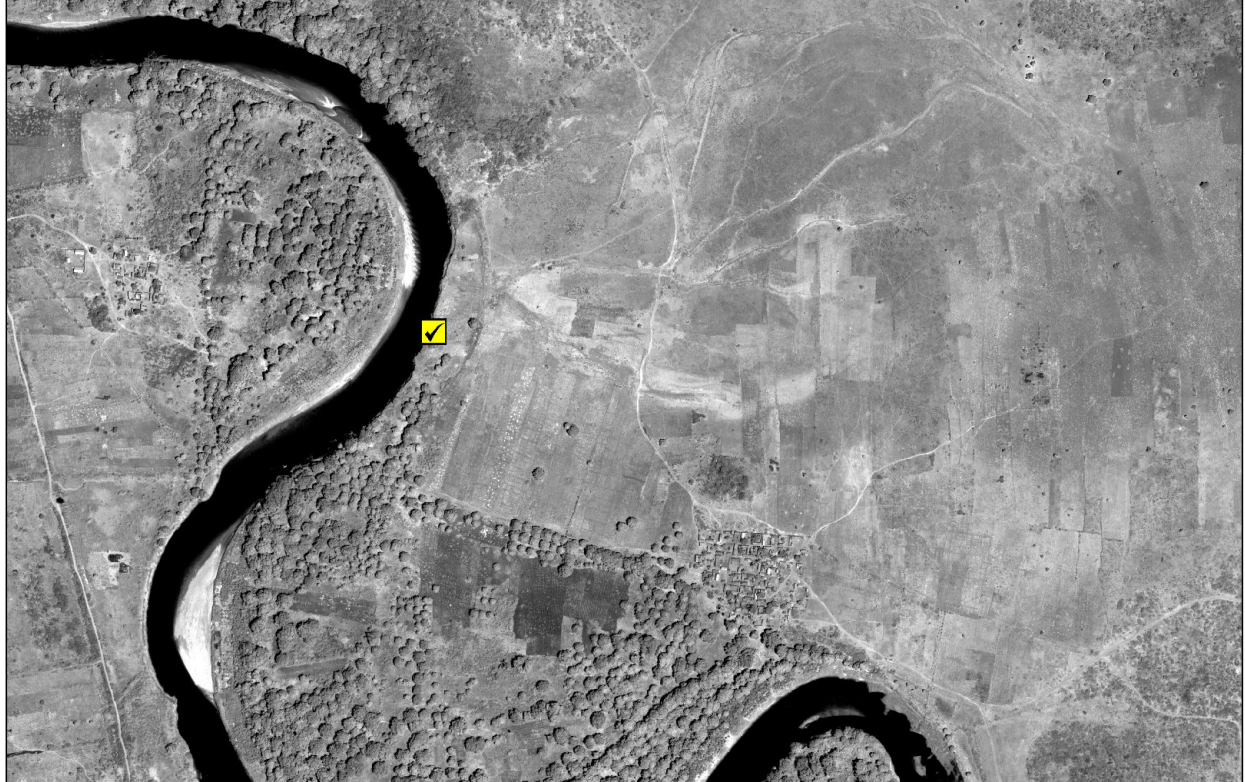
Gomeeni (19 Feb 13) - Images of 2012-13-14 show signs of water overflow branching from this area, indicating that previous major floods took place from here. However, no signs of recent flooding have been detected.
