**International Committee of the Red Cross (ICRC)  
Somalia Delegation**

**Water Resources Assessment, Water Supply  
Planning and Rehabilitation Surveys;  
Hydrogeological & Geophysical Surveys**

**Gedo Region - Somalia**

**January / February 2002**

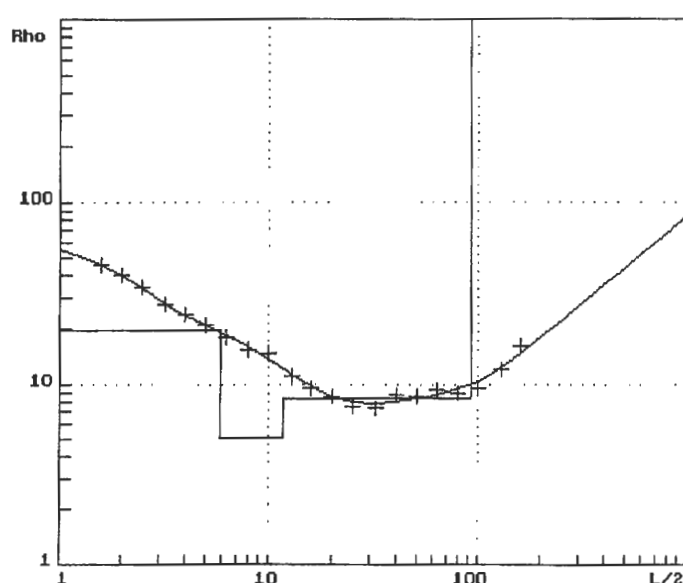
**Figure 26 - Results of Interpretation of VES 17**

Interpretation of the three VES indicate a superficial layer of resistivity varying between 47 and 1470 Ohm-m to a depth of up to 1 m bgl. This is interpreted to be dry top sandy soils, underlain by 6 to 20 Ohm-m layer to a depth of 5 to 6 m bgl. They are underlain by a 1.5 to 5 Ohm-m layer to a depth of 12 to 14 m bgl interpreted to be clays. These are underlain by a 1.5 to 15 Ohm-m layer to a depth of 66 to 92 m bgl. This is expected to be brackish water saturated weathered limestones and sandstones. Below this is the hard compact limestones and sandstones. At this village both shallow, medium and deep groundwater exists but the aquifer is saline as depicted by the low resistivity values.

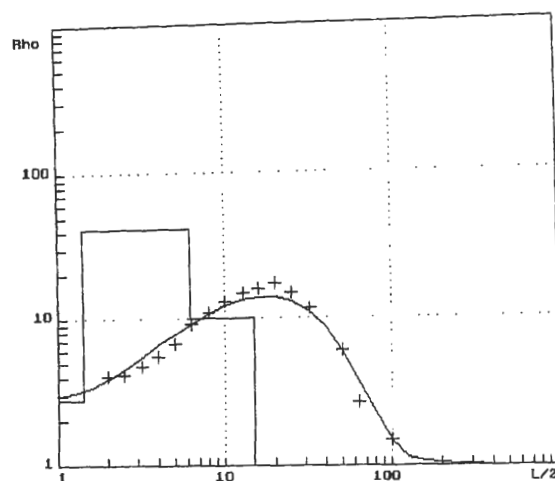
Figure 32 - Interpretation Graph for VES 24

is underlain by a 10 Ohm-m resistivity layer to a depth of 15 m bgl corresponding to highly weathered limestones with brackish water. The bottom layer is a 1 Ohm-m resistivity layer interpreted to be weathered limestones/sandstones with saline water.

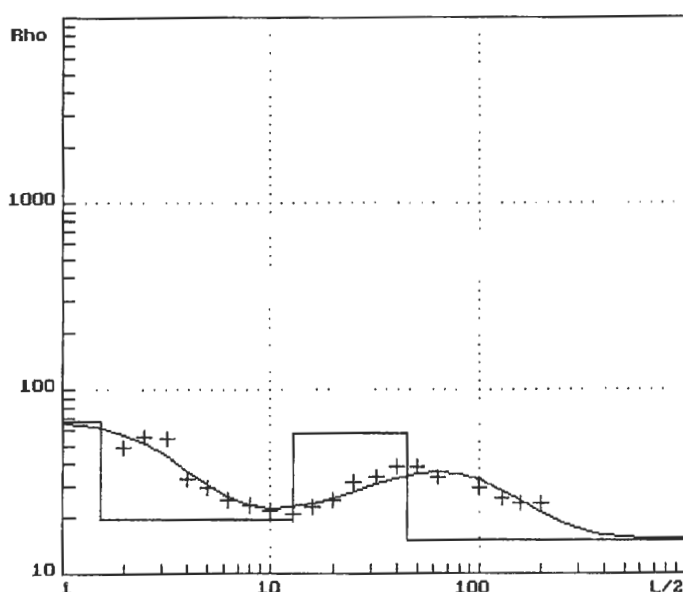
Figure 38 - Interpretation Graph for VES 32

The VES interpretation results indicate a superficial layer of 68 Ohm-m resistivity to a depth of 1.5 m bgl, comprising Recent deposits composed of sandy soils, underlain by a 20 Ohm-m resistivity layer to a depth of 13 m bgl comprising highly weathered limestones with fresh water. It is underlain by a 58 Ohm-m resistivity layer to a depth of 45 m bgl interpreted to be weathered limestones with fresh water. The bottom layer has a resistivity of 15 Ohm-m and is interpreted to be weathered limestones/sandstones with brackish water.

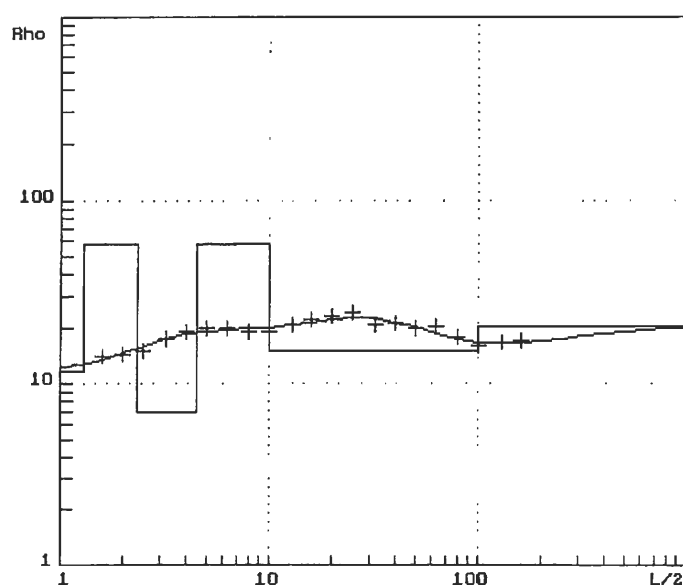
**Figure 41 - Interpretation Graph for VES 36**

The VES interpretation results indicate a superficial layer of 11.7 Ohm-m resistivity to a depth of 1.3 m bgl, comprising Recent deposits composed of silty top soils, underlain by a 58 Ohm-m resistivity layer to a depth of 2.3 m bgl comprising weathered limestones. It is underlain by a 8 Ohm-m resistivity layer to a depth of 4.5 m bgl interpreted to be highly decomposed limestones and clays. This is underlain by a 58 Ohm-m layer to a depth of 10 m bgl interpreted to be highly weathered limestones with fresh water. It is underlain by a 15 Ohm-m layer to a depth of 100 m bgl interpreted to be highly weathered limestones with brackish water. The bottom layer has a resistivity of 21 Ohm-m and is interpreted to be highly weathered limestones/sandstones with fresh to brackish water.

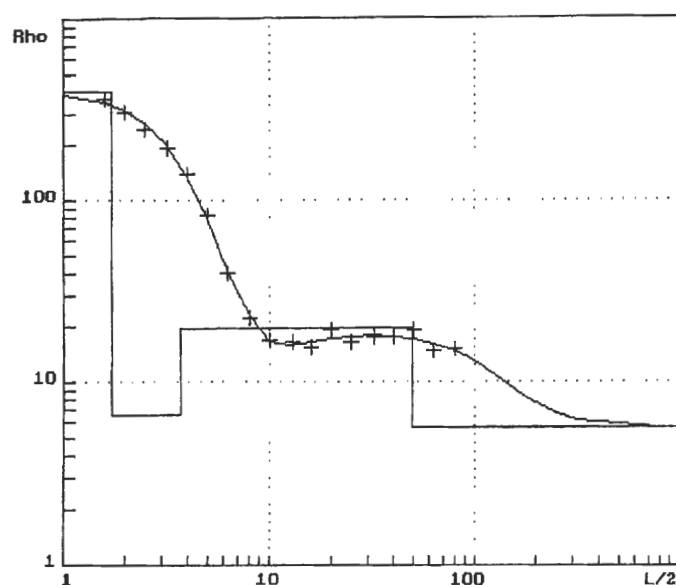
Figure 42 - Interpretation Graph for VES 37

The VES interpretation results indicate a superficial layer of 395 Ohm-m resistivity to a depth of 1.7 m bgl, comprising Recent deposits composed of sandy top soils, underlain by a 6.7 Ohm-m resistivity layer to a depth of 4 m bgl comprising highly weathered limestones and clays. It is underlain by a 20 Ohm-m resistivity layer to a depth of 49 m bgl interpreted to be weathered limestones with brackish water. The bottom layer has a resistivity of 5.6 Ohm-m and is interpreted to be highly weathered limestones/sandstones with saline water.

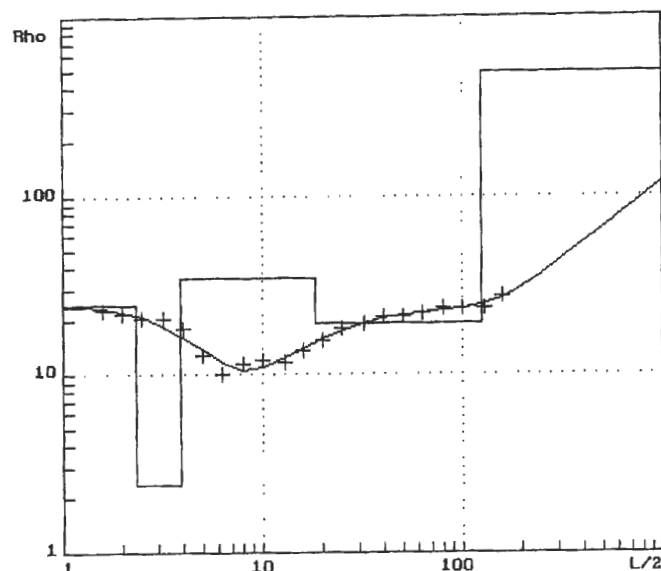
Figure 44 - Interpretation Graph for VES 40

The VES interpretation results indicate a superficial layer of 24 Ohm-m resistivity to a depth of 2.4 m bgl, comprising Recent deposits composed of sandy top soils, underlain by a 2.4 Ohm-m resistivity layer to a depth of 4 m bgl comprising clays. It is underlain by a 35 Ohm-m resistivity layer to a depth of 18 m bgl interpreted to be weathered limestones. This is underlain by a 19 Ohm-m resistivity layer to a depth of 125 m bgl interpreted to be highly weathered limestones with fresh water. The bottom layer has a resistivity of 487 Ohm-m and is interpreted to be fresh limestones/sandstones.

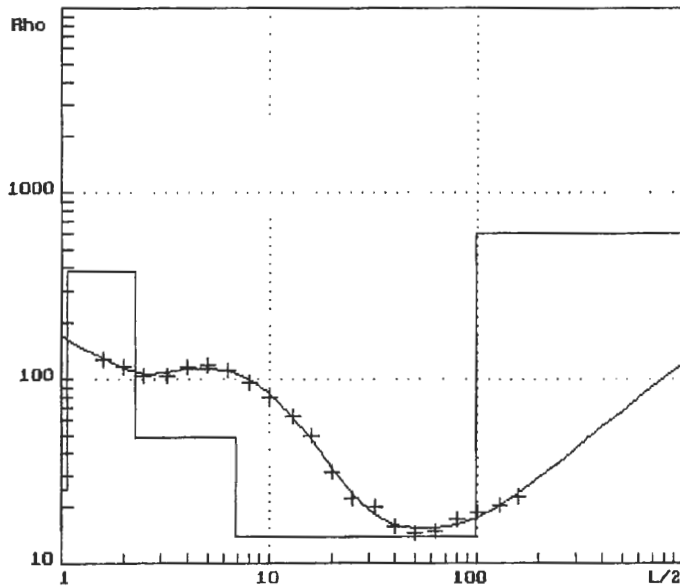
Figure 45 - Interpretation Graph for VES 41

The VES interpretation results indicate a superficial layer of 230 Ohm-m resistivity to a depth of 0.7 m bgl, comprising Recent deposits composed of sandy top soils, underlain by a 25 Ohm-m resistivity layer to a depth of 1 m bgl comprising silt. It is underlain by a 380 Ohm-m resistivity layer to a depth of 2.2 m bgl interpreted to be weathered limestones. This is underlain by a 49 Ohm-m resistivity layer to a depth of 6.8 m bgl interpreted to be weathered sandstones. This is underlain by a 14 Ohm-m resistivity layer to a depth of 98 m bgl interpreted to be weathered sandstones with fresh to brackish water. The bottom layer has a resistivity of 607 Ohm-m and is interpreted to be fresh sandstones.

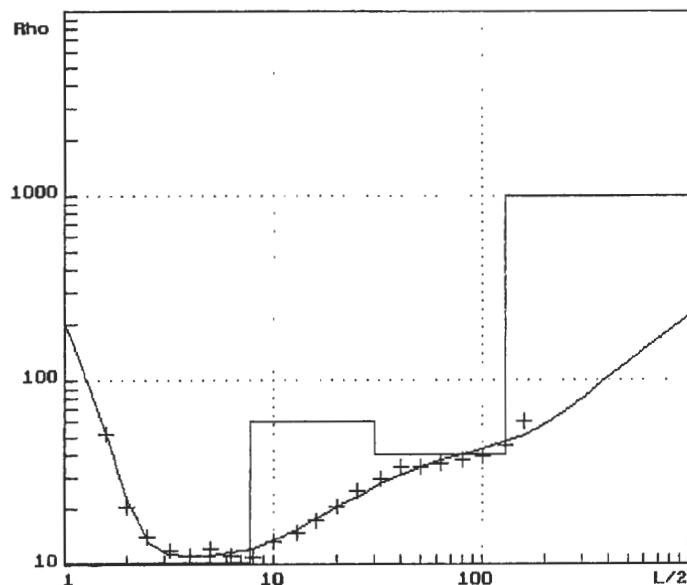
Figure 49 - Interpretation Graph for VES 45

The VES interpretation results indicate a superficial layer of 731 Ohm-m resistivity layer to a depth of 0.4 m bgl, comprising Recent deposits composed of sandy top soils, underlain by a 10.3 Ohm-m resistivity layer to a depth of 7.8 m bgl comprising clays. It is underlain by a 60 Ohm-m resistivity layer to a depth of 30 m bgl interpreted to be weathered limestones. This is underlain by a 40 Ohm-m resistivity layer to a depth of 130 m bgl interpreted to be highly weathered limestones with fresh water. The bottom layer has a resistivity of 1000 Ohm-m and is interpreted to be hard compact fresh limestones/sandstones.

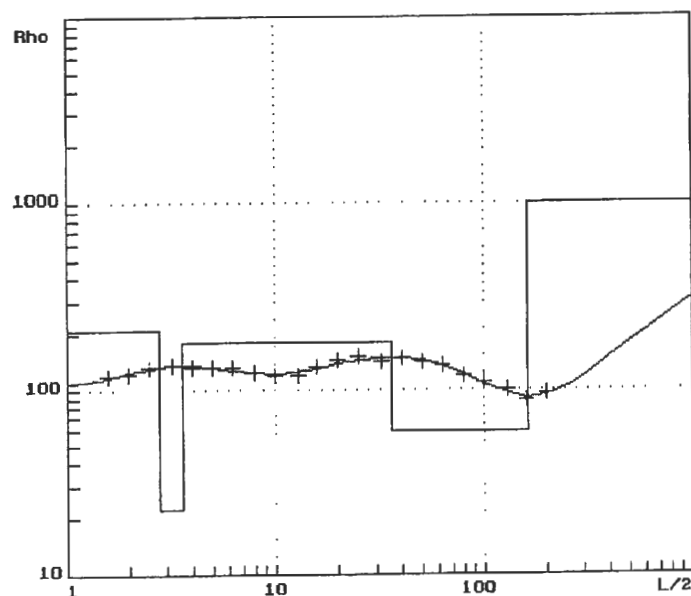
Figure 50 - Interpretation Graph for VES 46

The VES interpretation results indicate a superficial layer of 102 Ohm-m resistivity layer to a depth of 1 m bgl, comprising sandy top soils, underlain by a 209 Ohm-m resistivity layer to a depth of 2.8 m bgl hard fresh sandstones. It is underlain by a 22 Ohm-m resistivity layer to a depth of 3.6 m bgl interpreted to be weathered sandstones. This is underlain by a 181 Ohm-m resistivity layer to a depth of 36 m bgl interpreted to be hard fresh sandstones. This is underlain by a 59 Ohm-m resistivity layer to a depth of 161 m bgl interpreted to be highly weathered sandstones with fresh water. The bottom layer has a resistivity of 1000 Ohm-m and is interpreted to be hard compact fresh limestones/sandstones.

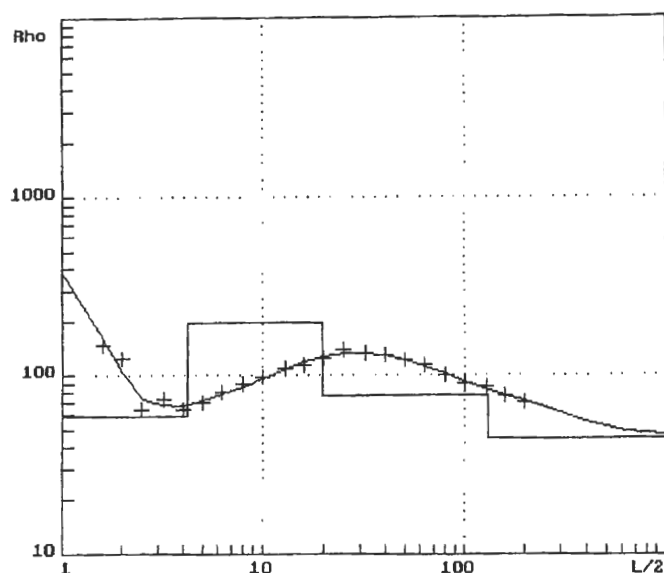
## VES 47

The VES interpretation results indicate a 894 Ohm-m resistivity layer to a depth of 0.5 m bgl, comprising sandy top soils, underlain by a 58 Ohm-m resistivity layer to a depth of 4.2 m bgl interpreted to be weathered sandstones. It is underlain by a 196 Ohm-m resistivity layer to a depth of 19.5 m bgl interpreted to be hard fresh sandstones. This is underlain by a 78 Ohm-m resistivity layer to a depth of 132 m bgl interpreted to be weathered sandstones likely to have some aquifers with fresh water. The bottom layer has a resistivity of 45 Ohm-m and is interpreted to be highly weathered sandstones with fresh water.

Figure 51 - Interpretation Graph for VES 47

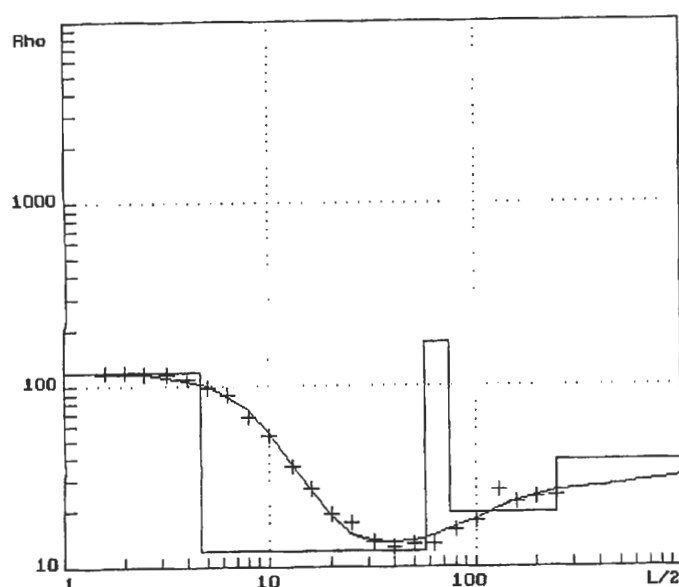
#### VES 50

The Ec of the borehole water is reported to be 8,000  $\mu\text{S}/\text{cm}$  which is considered to be brackish but nevertheless used for animal consumption.

Figure 54 - Interpretation Graph for VES 50

In view of the fact that the borehole water supply when operational used to meet the requirements for the village the following is recommended:-

- 1) Remove the pump and inspect the borehole i.e. measure the depth, water level.
- 2) Installation of the generator and pump.
- 3) Rehabilitation of the piping system
- 4) Construction of 2 animal troughs and repair of old ones
- 5) 1 set of 6 water delivery tap stands

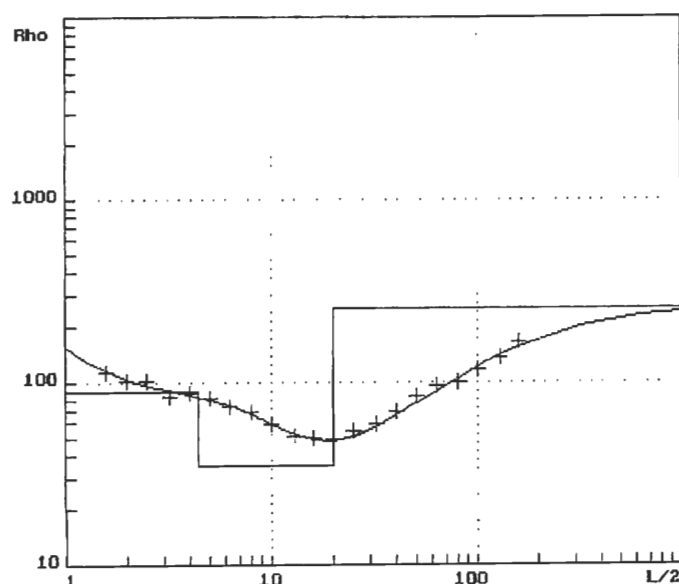
## VES 51

The Ec of the shallow wells was measured to be 9300 and 8300  $\mu\text{S}/\text{cm}$  for the two wells spaced approximately 1 km apart each other. The water quality is considered to be brackish, but nevertheless used for domestic and animal consumption.

Figure 55 - Interpretation Graph for VES 51
