AFRICA - Somalia

Open Breakage Sites along River Juba as at August 2021				
ID	District	Nearest Settlement	Width Estimate (m)	Verification Status
1	Jamaame	Beled Amiin	3	VHR Verified
2	Jamaame	Beled Amiin	10	VHR Verified
3	Jamaame	Gomeeni	12	VHR Verified
4	Jamaame	Maama	6	VHR Verified
5	Kismaayo	Gaduud	8	VHR Verified

Map Reference:  
SOM\_WAT\_JAMAME\_JUBA\_RIVER\_BREAKAGES\_SWALIM\_25082021\_A3

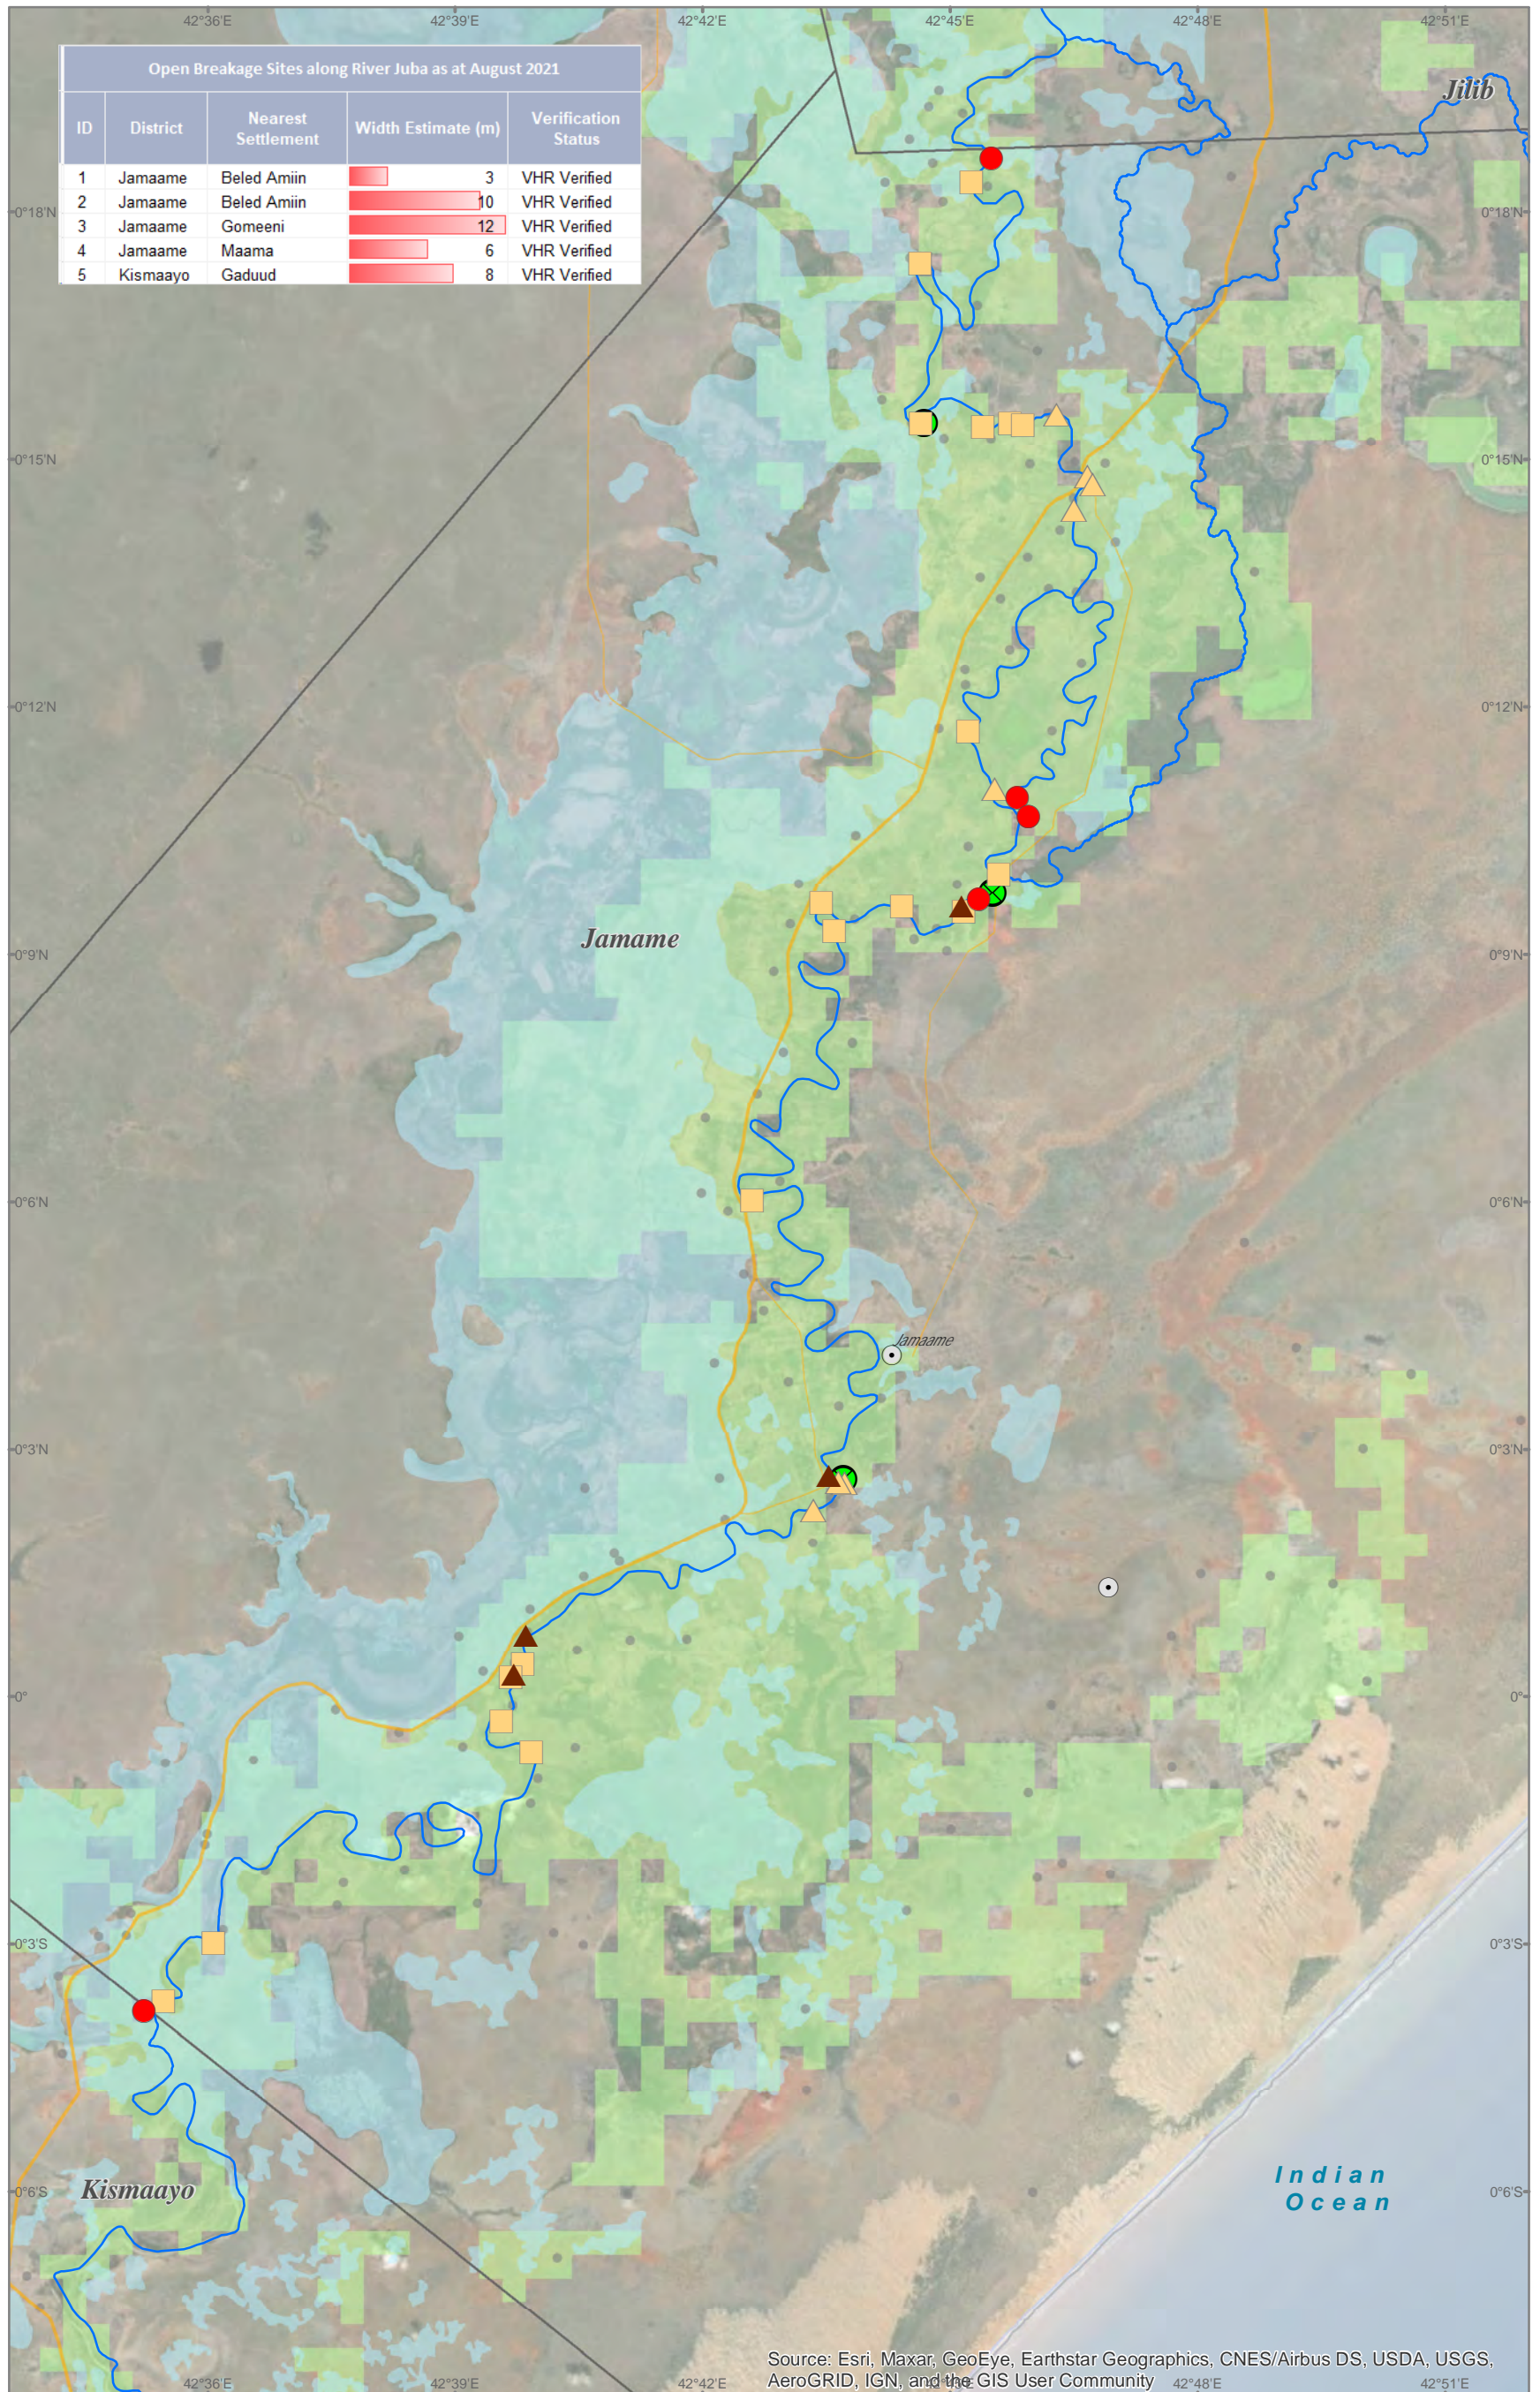
Caution:  
Verified Breakage : Confirmed this season through VHR Images and/ Field Verification

Not Verified Breakage: Confirmed in previous season but there was either cloudy or no VHR Image for assessment this season
