FINAL REPORT
WATER YARDS FOR
POTABLE WATER AND LIVESTOCK
IN
CENTRAL REGION, SOMALIA

Adventist Development and Relief Agency (ADRA)

March 1994

TITLE: Adale Water Project

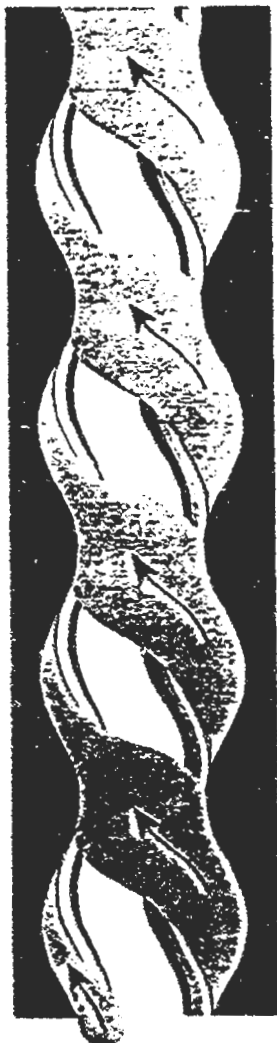
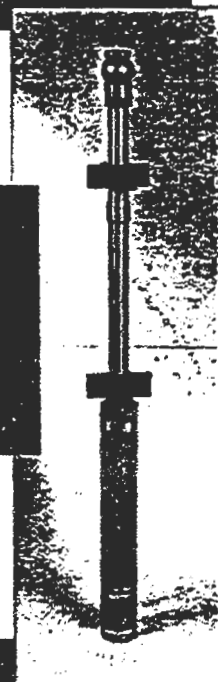
The Mono[®] pumping principle was invented in the 1930's, and has continued to be developed and refined to meet the increasing needs of the world's pumping industries.

The progressing cavity principle is one of the most efficient and reliable methods of pumping water ever developed by man. The design principle ensures that the pumps are also extremely reliable and can usually be expected to outlast multi-stage pumps, particularly on borehole water with a sand or silt content.

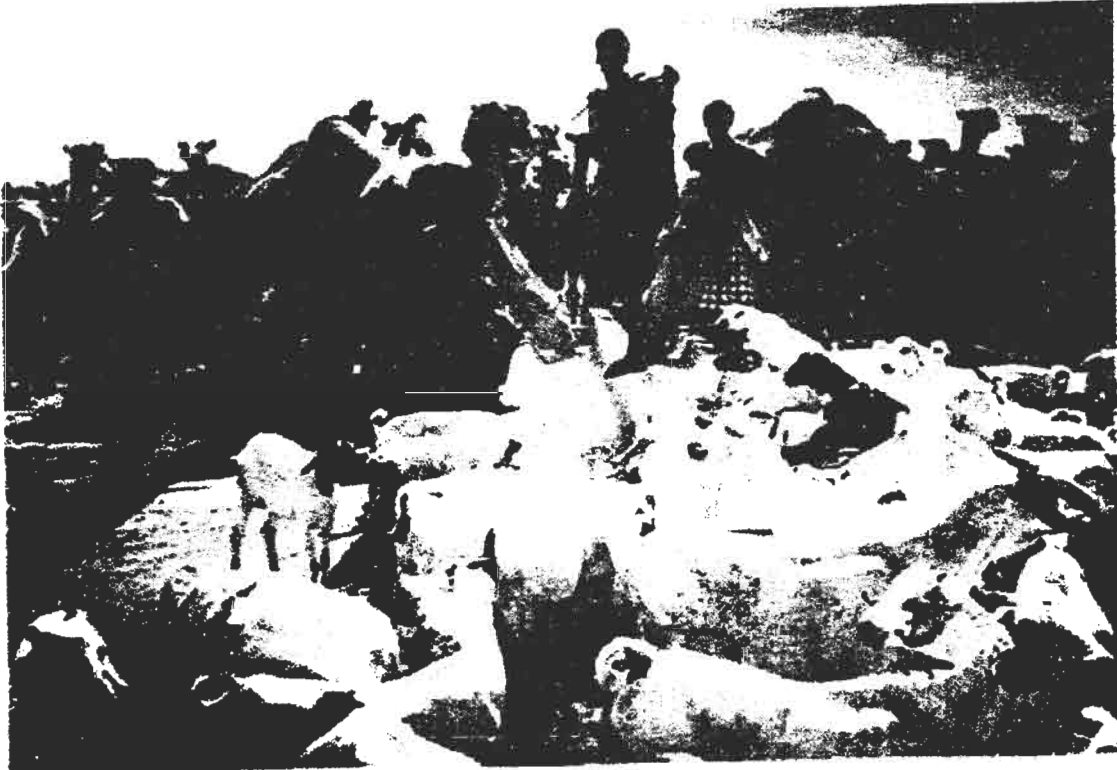
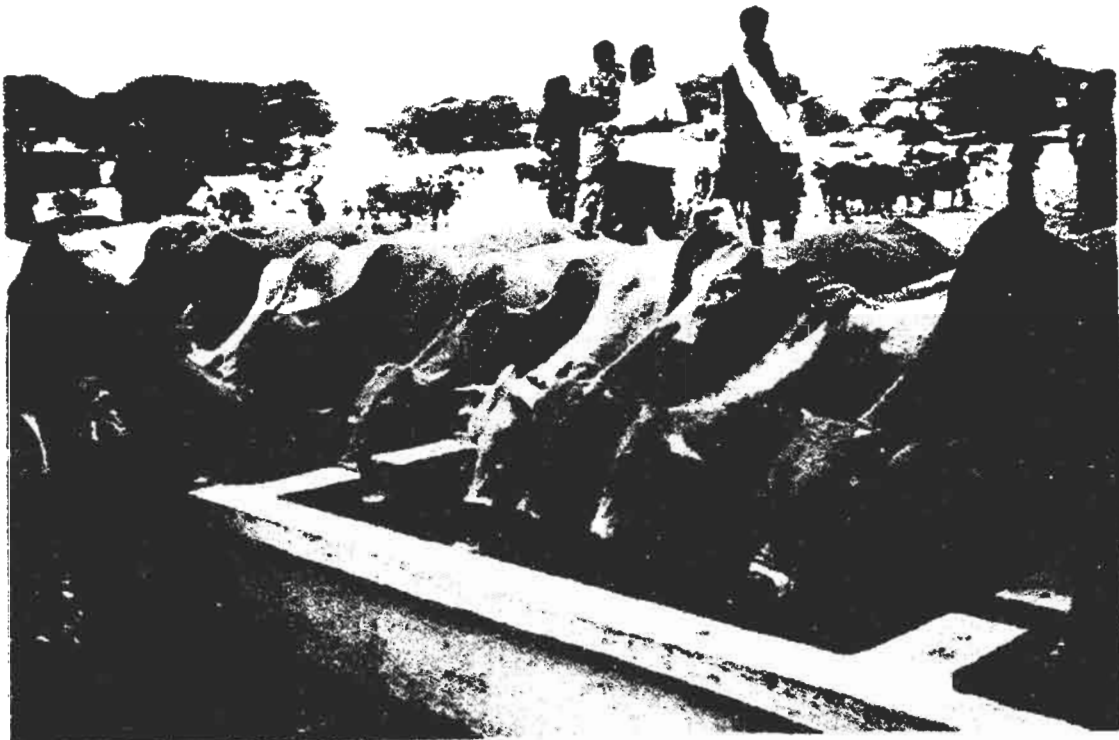
Photo 1

The first picture was taken at the village of Hagi Ali. The livestock trough for camels is filled with water. The second picture depicts a cattle trough, which is much lower than that of a camel trough. picture taken at Ali Gudud.

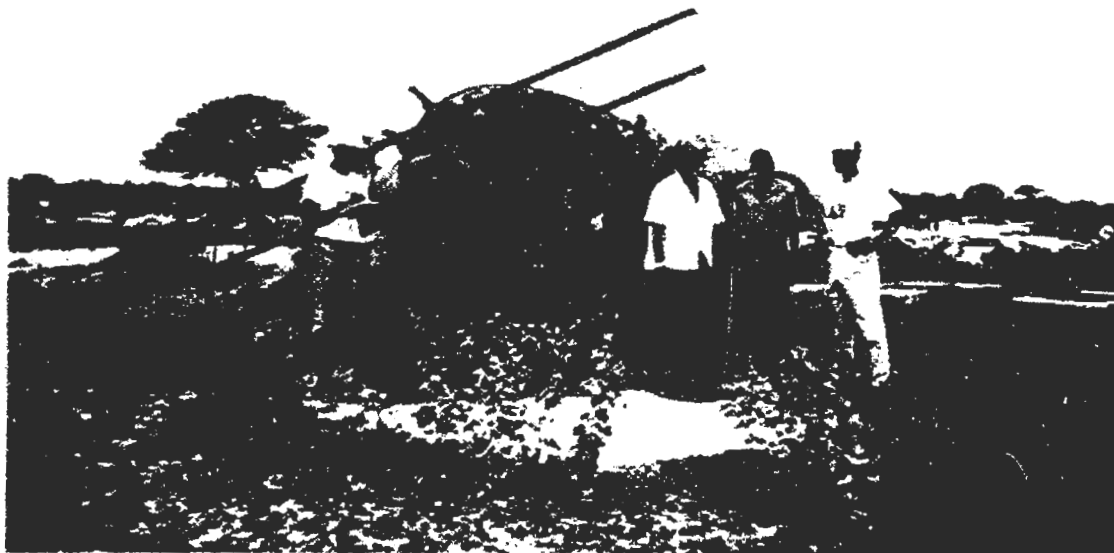
Photo 3

Picture one depicts old water tank of Geel-Gub. The following picture depicts a newly installed water tank. This is a type of the water tanks we purchased from Oxfam.

The old concrete water tank has been repaired and enlarged with a new 10,000L metal OXFAM water tank from galvanized material. A new distribution site with six public taps has been constructed and also a new trough specifically for camels. The old livestock trough has been repaired and it all has been connected with pipes.

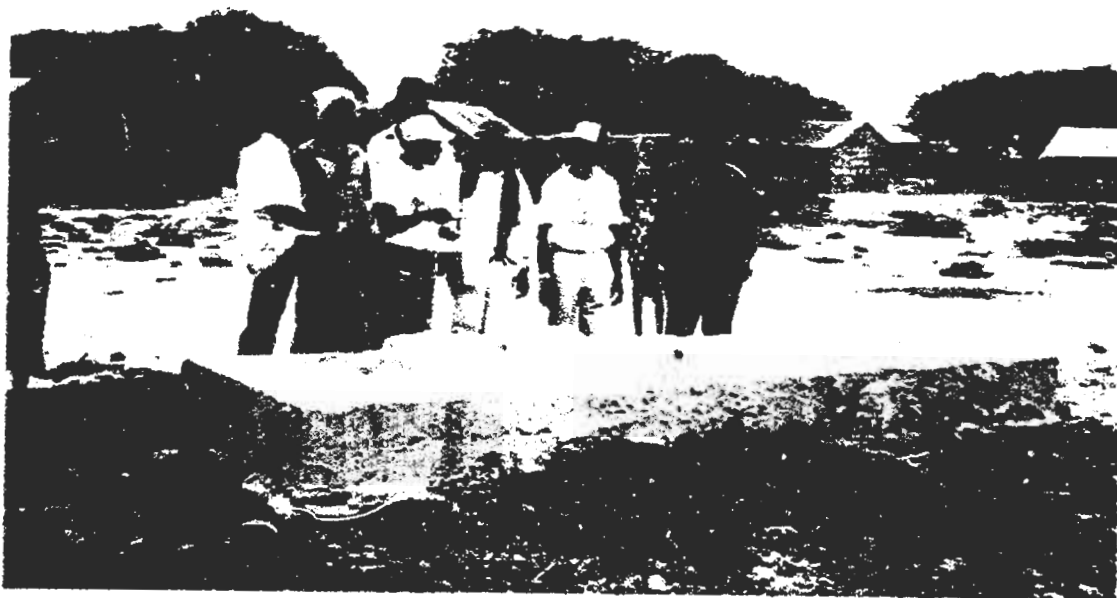
Photo 4

The provision of clean/potable water to both livestock and humans is major objective of ours. The following depicts a destroyed water distribution point in one of the villages. The next picture depicts a restored water distribution point with six outlets. This model was used in all the villages.

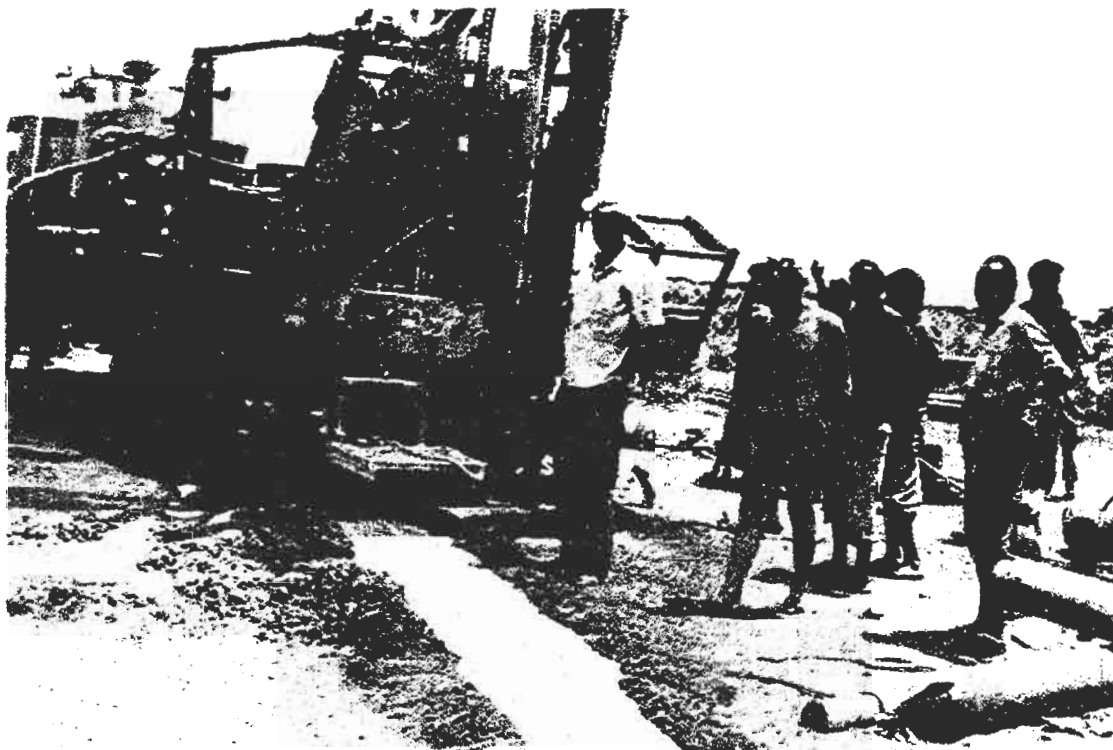
Photo 4.

The drilling tasks was accomplished by two drilling Rigs. The first drilling rig was not dependable, hence our contractor purchased a second rig, which was very reliable. The pictures depict the team at work.

It is a DEEP ROCK Model 155 and has been purchased new from the USA by Deqa Construction Co., in order to fulfill this water project. We have had a bad experience with hiring an old local rig. We did this for one well funded by the Canadian High Commission. But during the process of drilling this old rig had two breakdowns and it needed weeks for repairs. It was not feasible to continue with that rig for the Adale water project.

Some specifications for the new drilling rig we used: It has a rotary drill and is equipped with a 470 cubic feet per minute (cfm) air compressor at 200psi. It has a 3 x 4 centrifugal mud pump with a capacity of 300 gallons per minute (gpm). At 150psi it has a 9gpm John Bean water injection pump for air mist, air, water or foam drilling.
